Kari Uotila

Medieval Outer Baileys in Finland
With Special Reference to Turku Castle

Turku 1998

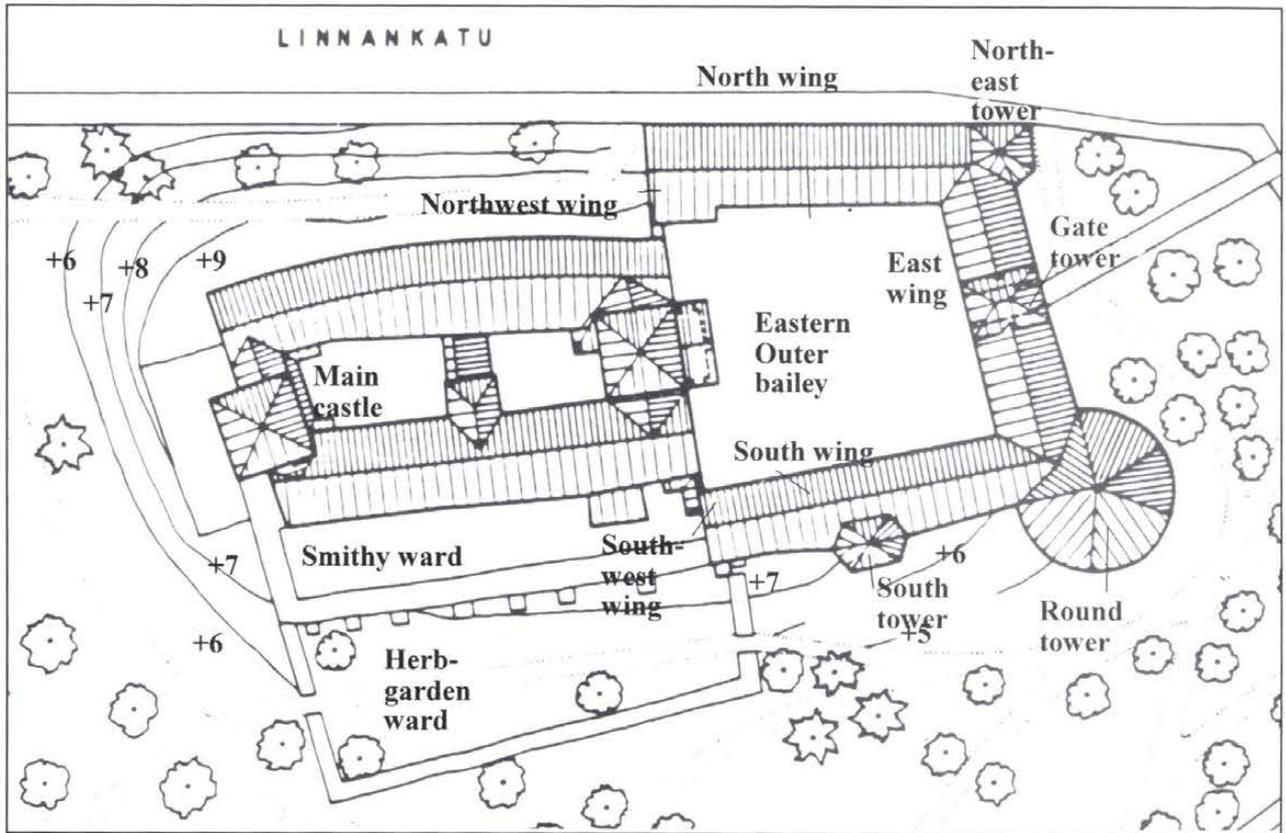
Fig. 4. Present-day Turku Castle consists of the main castle and the eastern outer bailey with its southwest, west, east, north and northwest wings. The outer bailey also has a hexagonal (south) tower, a round tower (overlying the older southeast tower), and a northeast tower. On the south side of the main castle are two wards, the middle and outer southern wards, which are known as the smithy ward (the gaol ward) and the herb ward. (Gardberg 1959, pp. 31-33, map in the archives of the Dept. of Monuments and Sites, NBA. Turku Castle. Redrawn by K. Uotila).

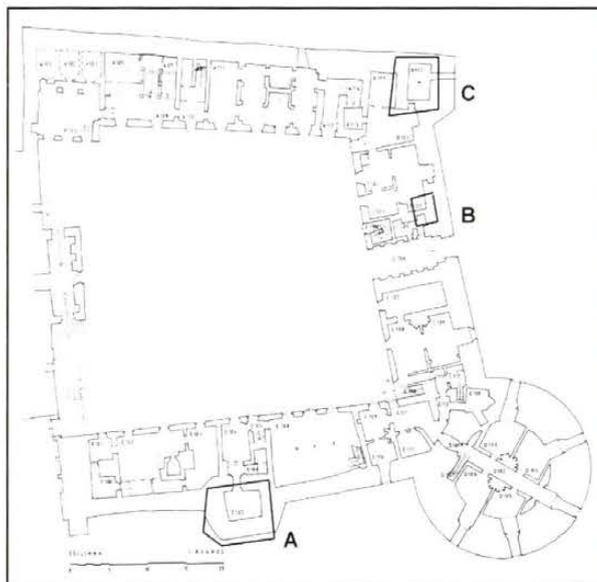
Fig. 10. Older timber structures and earth layers discovered beneath the walls of the east outer bailey of Turku Castle. A=south tower area, B=north side of the gate tower, C=northeast tower. (Archives of the Dept. of Monuments and Sites, NBA. Turku Castle. Redrawn by K. Uotila).

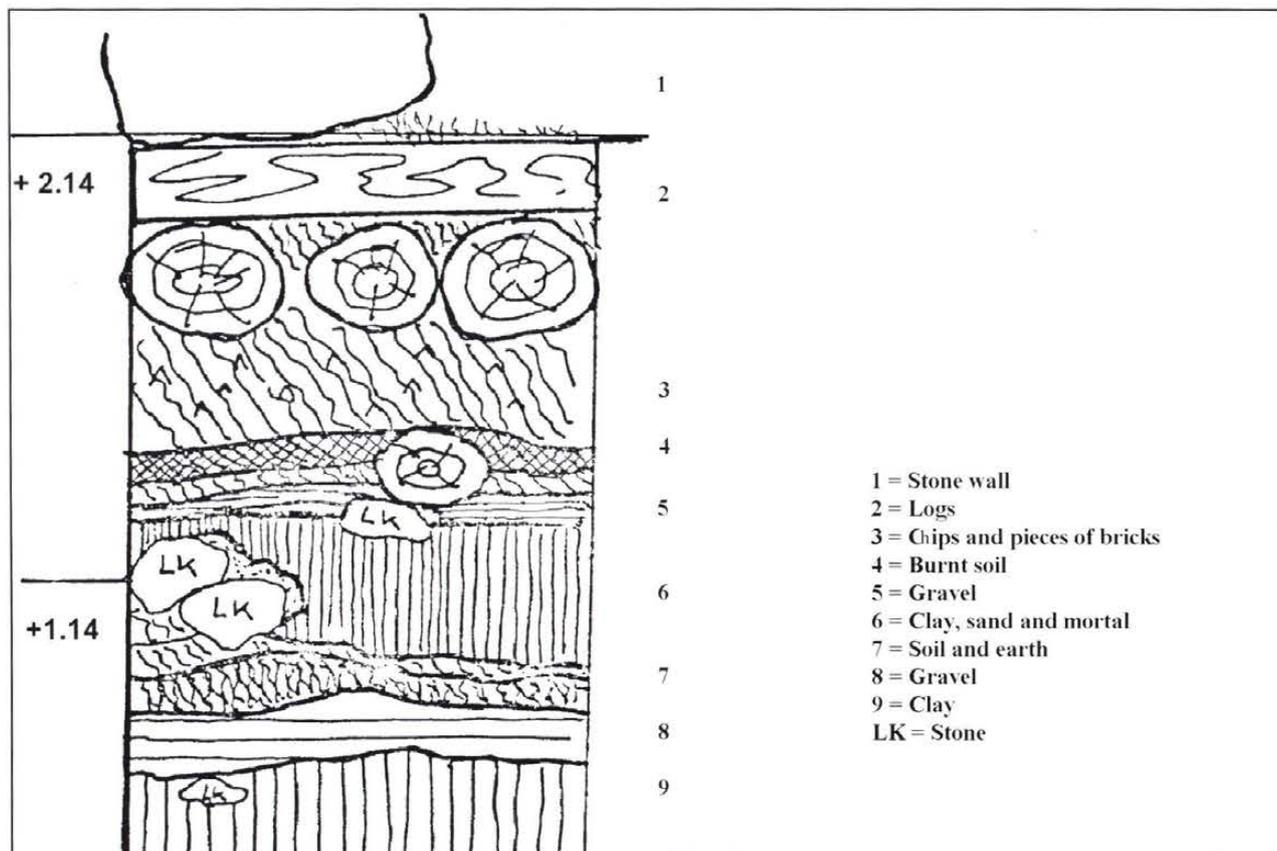
Fig. 11. Structures and earth layers from beneath the south wall of the east outer bailey of Turku Castle. The structures of the outer wall extend to approximately elevation +1.80, after follow almost one metre-thick mixed layers of soil and clay. Undisturbed clay begins at roughly +0.80. (Illustration from the Archives of the Dept. of Monuments and Sites, NBA. Turku Castle. Redrawn by K. Uotila).

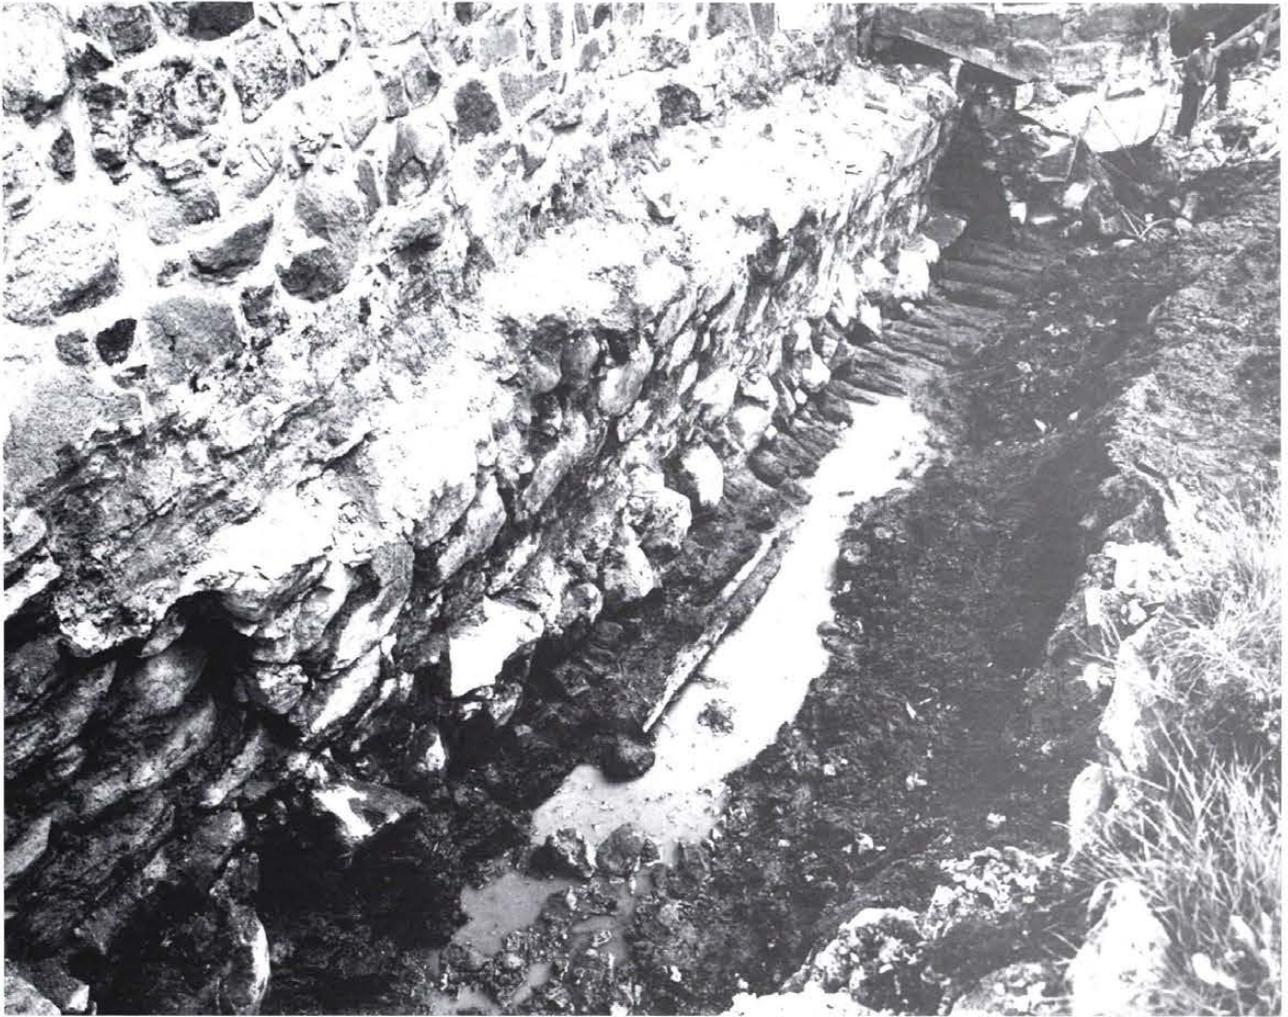
Fig. 16. The oldest south wall of the east outer bailey.

The lowest feature, overlaying the clay layer, is the double log framework of the oldest wall, which is followed by masonry of undressed stone. Both components have clearly leaned towards the Aurajoki River. The present south wall was later built on top of the leaning wall and laid out with a different course than the old wall. The upper of the illustration shows the revealed wall structures of the oldest south tower and the present hexagonal tower. (Photograph by P.O. Welin, Archives of the Dept. of Monuments and Sites, NBA, Turku Castle. Photo negative 2424)

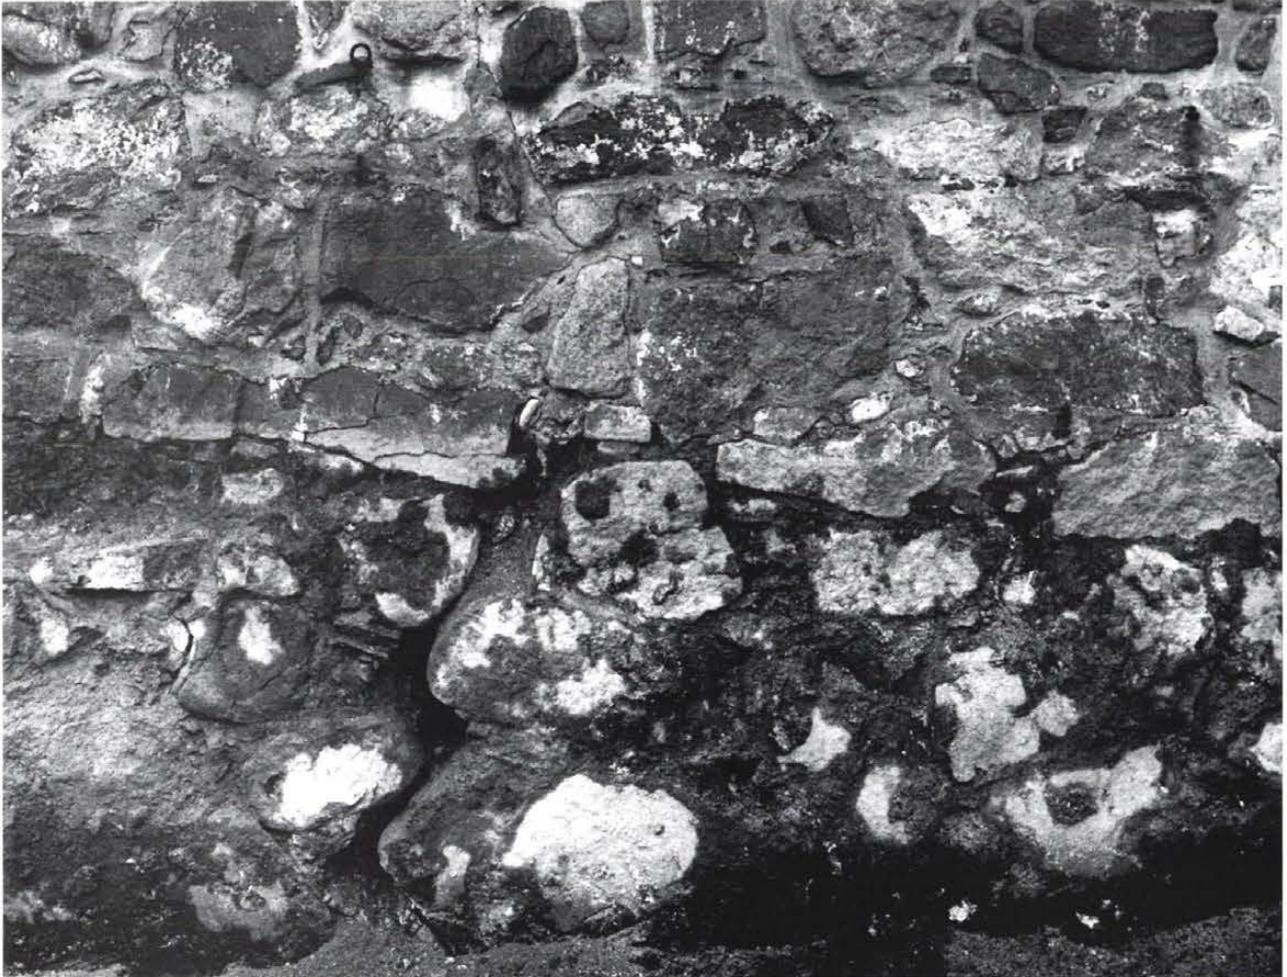
Fig. 17. The structures of the east outer bailey between the hexagonal tower (south tower) and the round tower. In the east section of the wall, the older wall part merges into the newer one without any distinct structural joint. There may be a possible joint at the large upright crack (centre of image), although the upper section is of uniform appearance. (Photograph by P.O. Welin, Archives of the Dept. of Monuments and Sites, NBA, Turku Castle. Photo negative 2394)

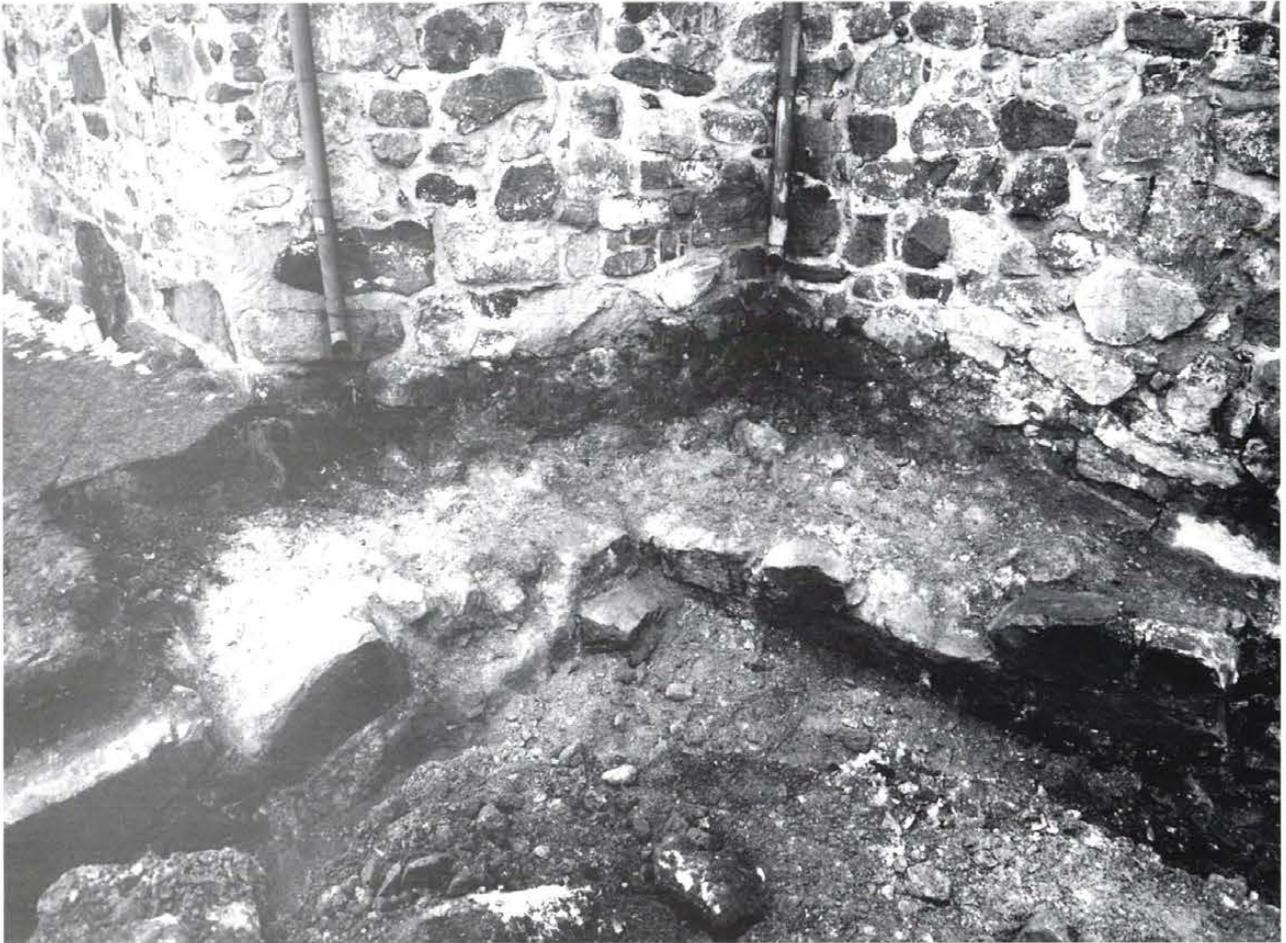
Fig. 18. The south wing of the east outer bailey

There are no definite building-archaeological observations that could establish the respective order of building of the oldest south tower (lower left) and the east section of the outer wall, but it is highly probable that both were built in the first stage of construction. (Photograph by P.O. Welin, Archives of the Dept. of Monuments and Sites, NBA. Turku Castle. Photo negative 2390)

Excavations in middle section of the south wall in the 1950s and 1970s revealed the outer walls of an older quadrangular tower located at the site of the present south tower (the so-called hexagonal tower). The inner walls of the old tower are situated beneath the foundation of the lowest room in the present south tower, where they were also documented in excavations carried out in the 1970s (Fig. 18).

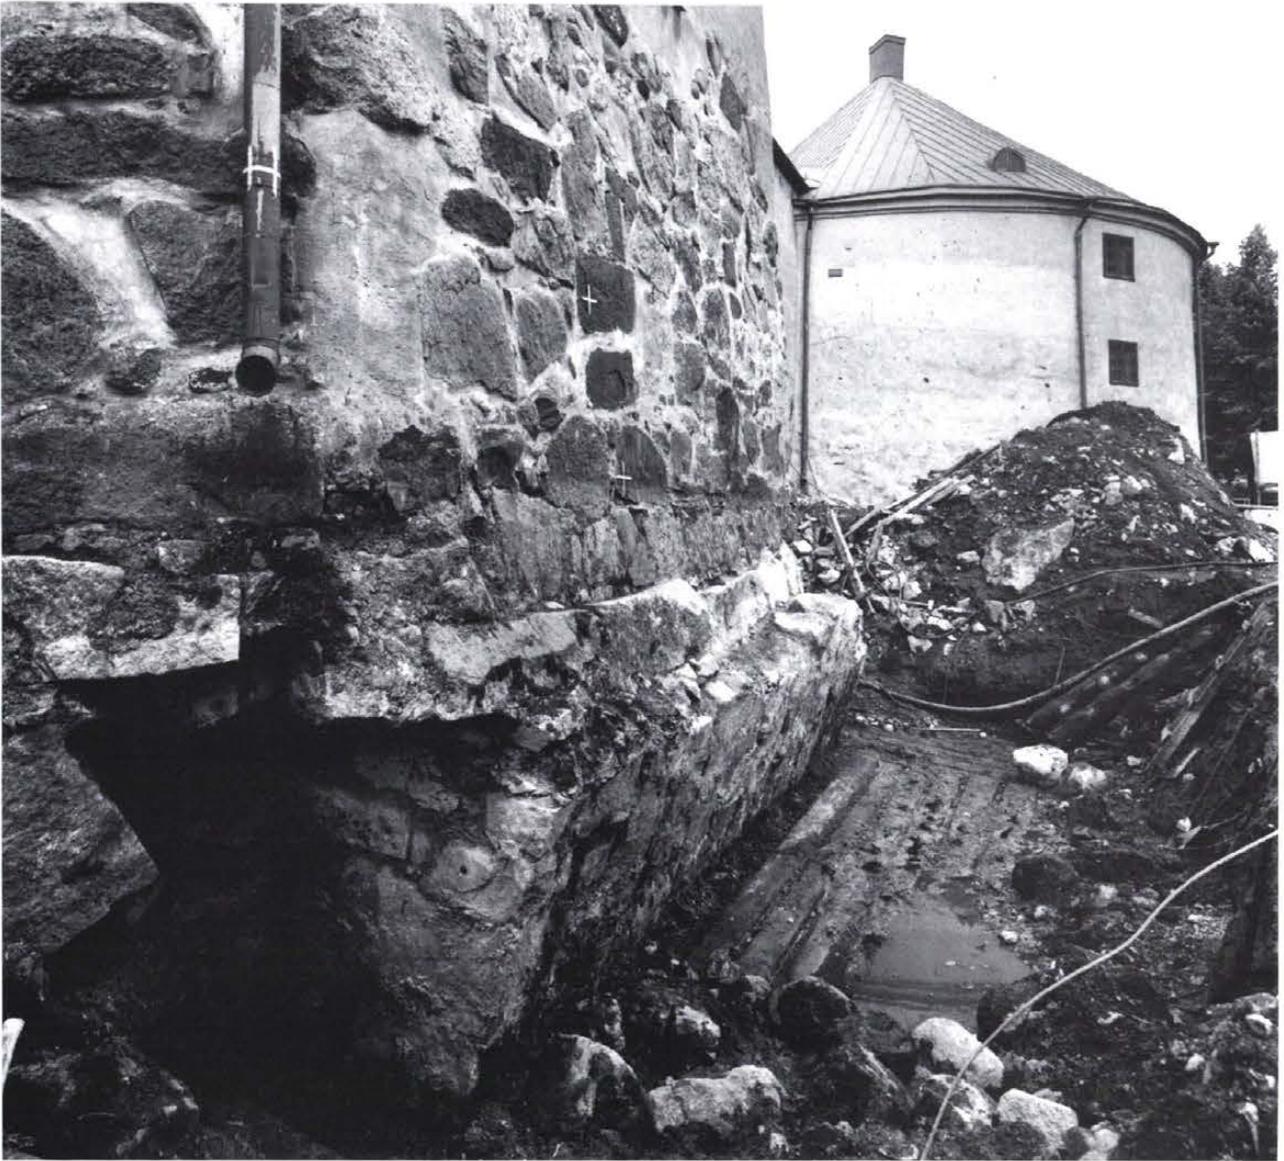
Fig. 19. The south tower of the east outer bailey of Turku Castle.

In the foreground are the wall structures of the leaning south tower and to the right of the tower is the log foundation of a support structure demolished during repairs. The picture clearly shows how the old tower leaned more than the support on the south side. It appears that the support structure was built to adjoin the tower that already leaned. A new hexagonal south tower was built on top of the walls of the old tower with the leaning walls as its foundation. (Photograph by P.O. Welin, Archives of the Dept. of Monuments and Sites, NBA. Turku Castle. Photo negative 2426)

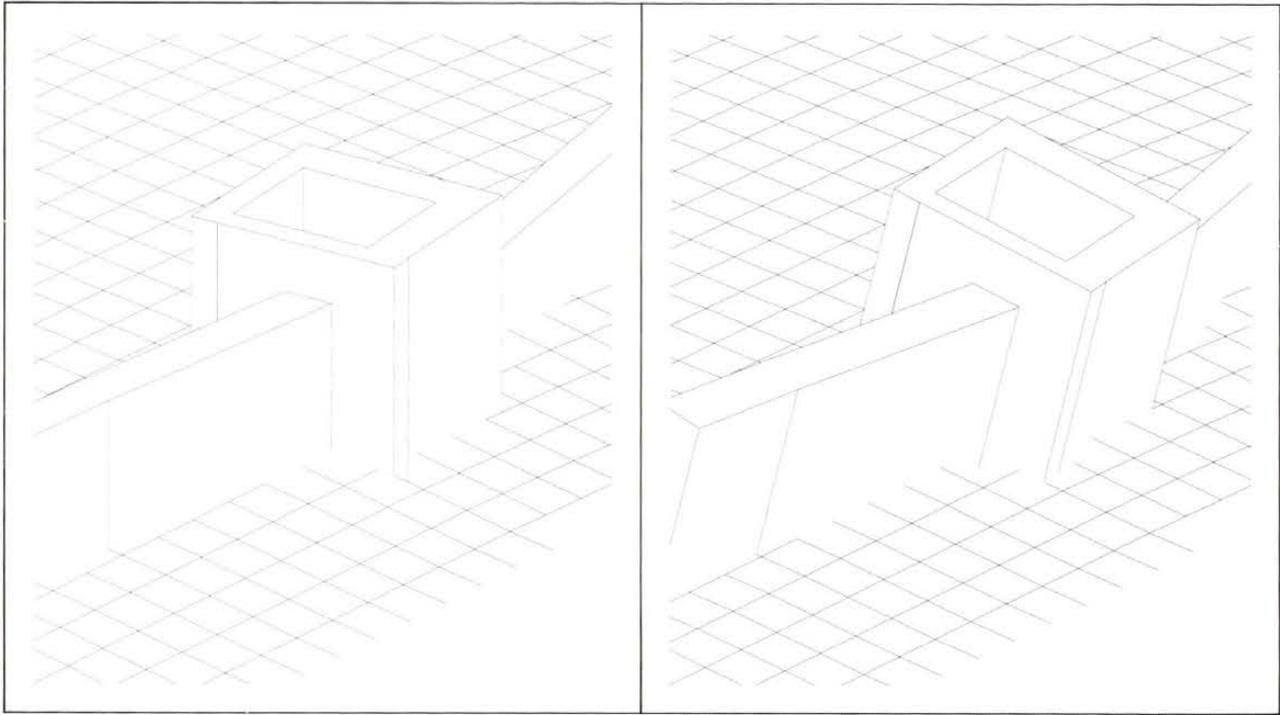
Fig 20. The oldest masonry-built south tower and the west section of the south wall lean by some 14-17 degrees towards the Aurajoki River (14 degrees in the illustration).

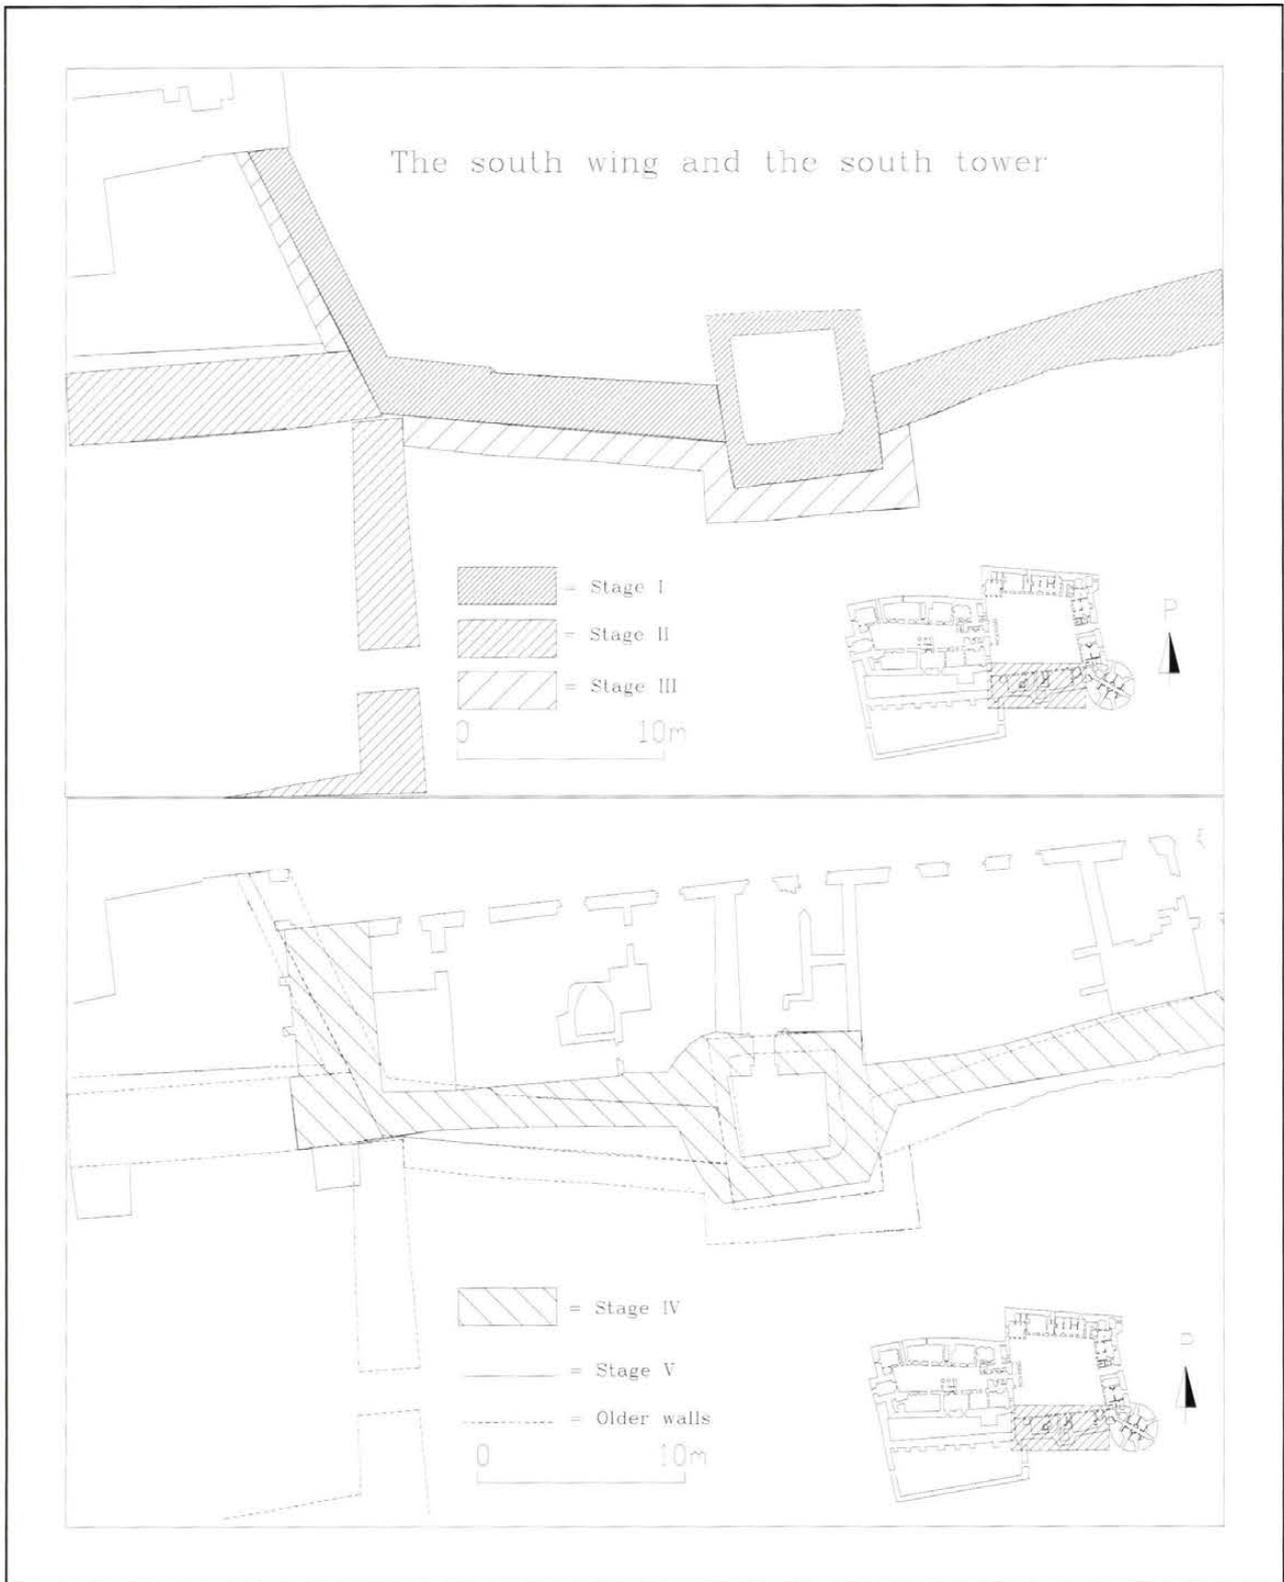
Fig 21. History of construction of the south part of the east outer bailey of Turku Castle (by K.Uotila).

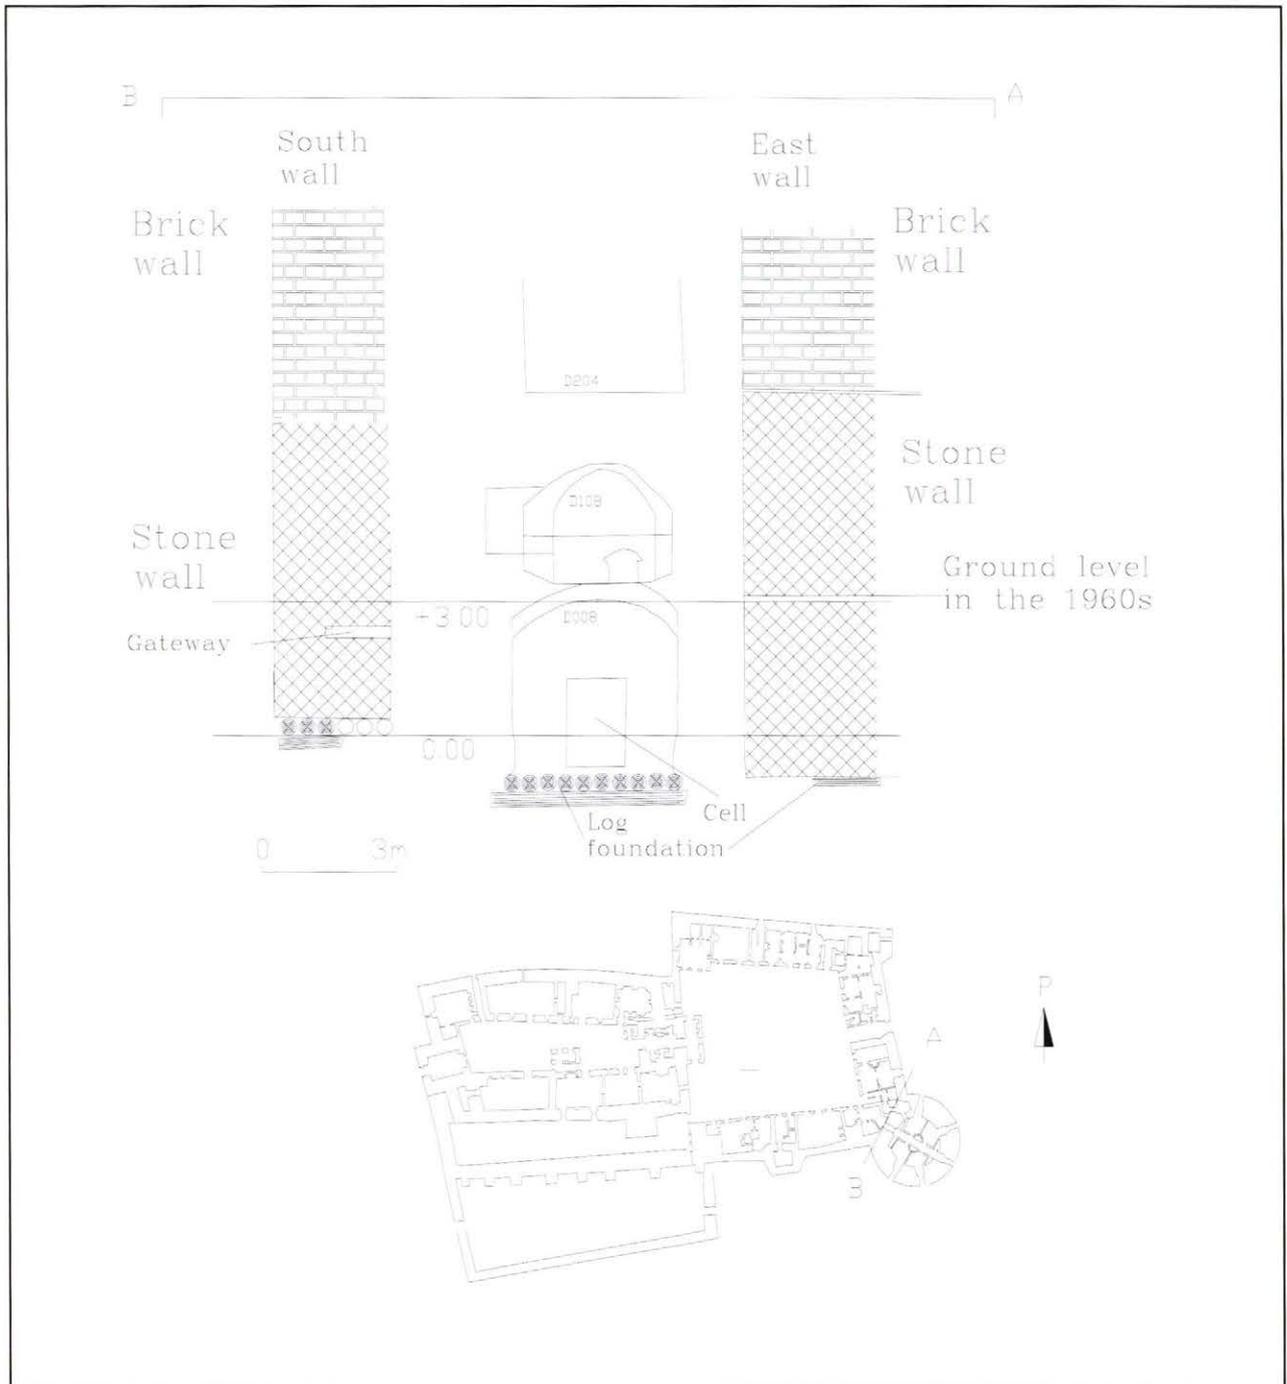
Fig. 25. The east outer bailey of Turku castle. Building-archaeological data on the walls of rooms D008 and D108 of the southeast tower and other older walls in the area of the round tower. Section. (Illustration by K. Uotila)

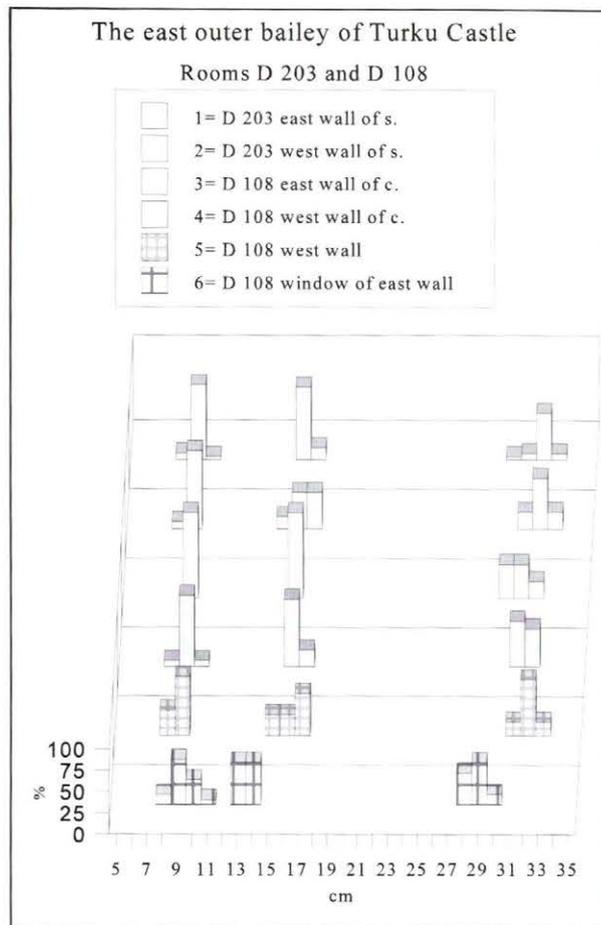
Fig 27. The east outer bailey of Turku Castle. Size of bricks in various components (D 203 and D 108) of the older southeast tower.

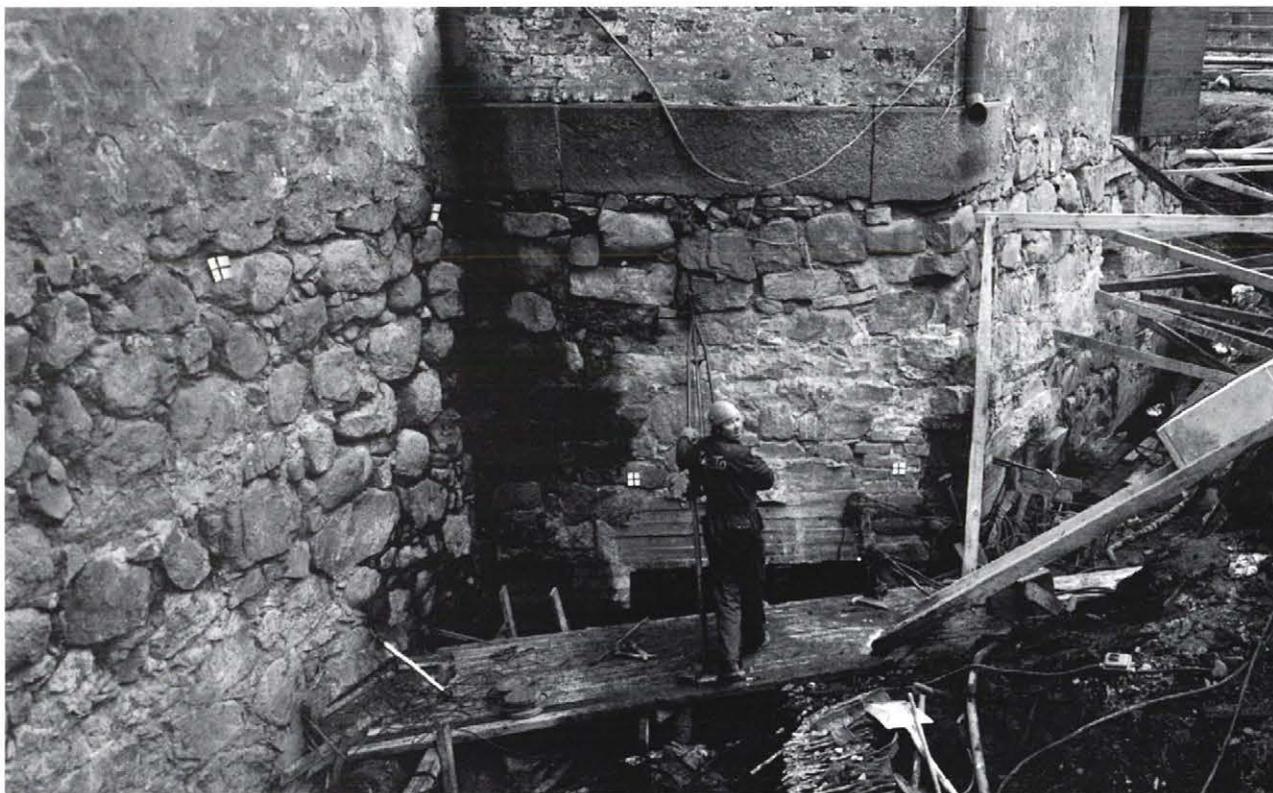
Fig. 30. East outer bailey of Turku Castle. Repairs to the east wing and northeast tower in 1975. Present ground level is shown by the mortar-covered surface of the stone walls. The south wall of the northeast tower was clearly built jointed to the east wall on the left. Detailed investigations of the tower showed that behind the present angled wall is the original straight south wall. (Archives of the Dept. of Monuments and Sites, NBA, Turku Castle. Photo by P.O. Welin)

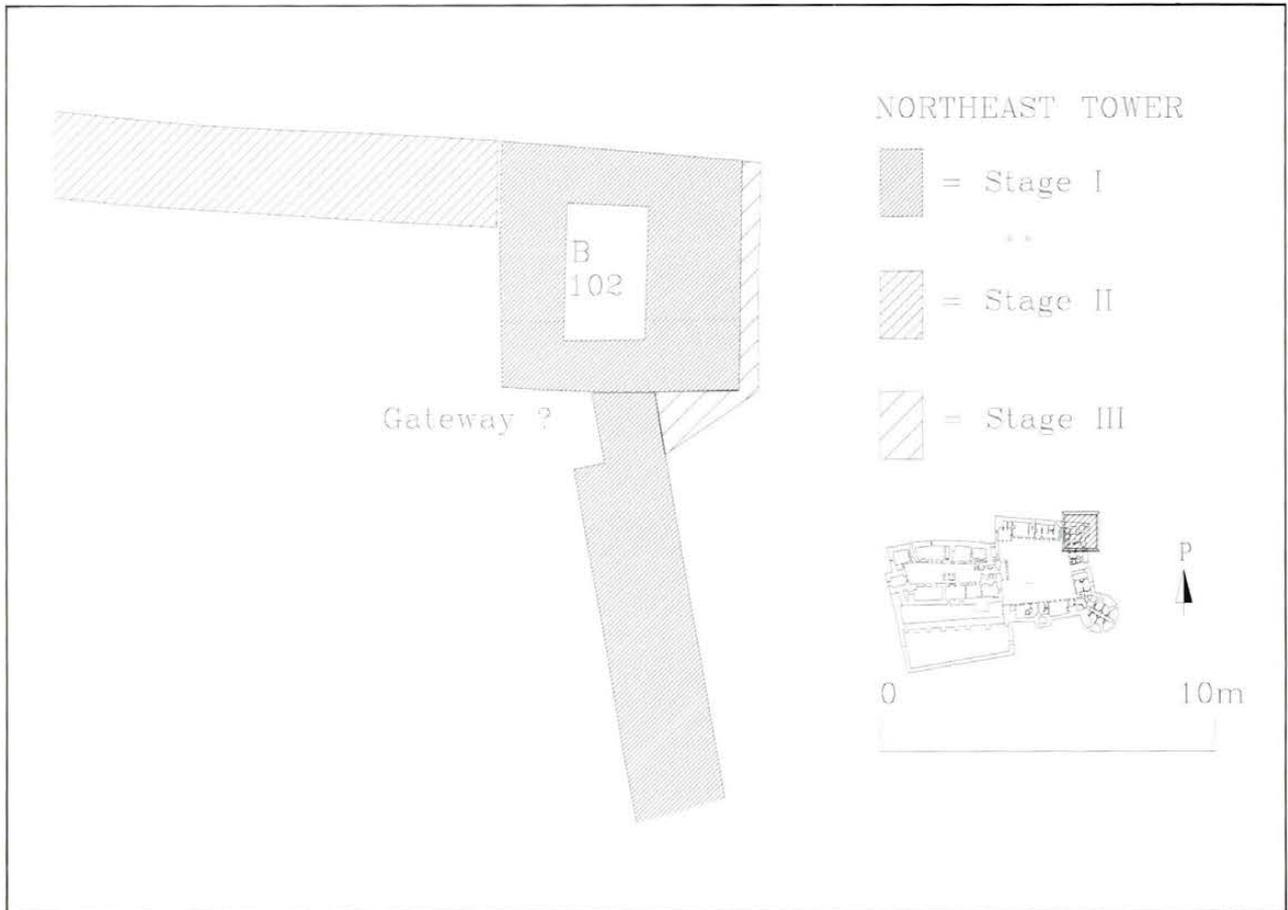
Fig. 33. History of construction of the northeast tower of the east outer bailey of Turku Castle. (Drawing by K. Uotila)

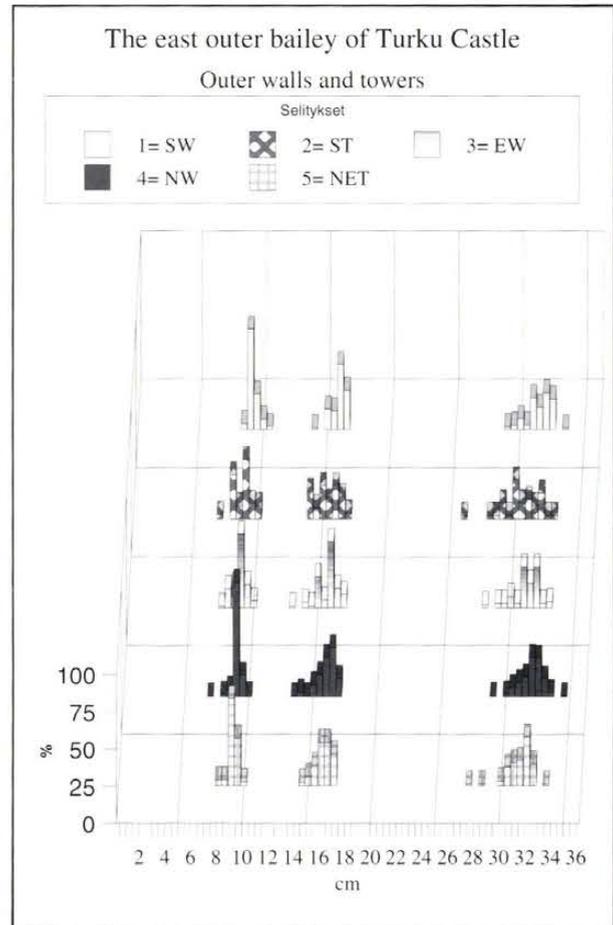
Fig. 35. The eastern outer bailey of Turku Castle. Brick size in the outer faces of the outer walls and towers of the outer bailey and the towers.

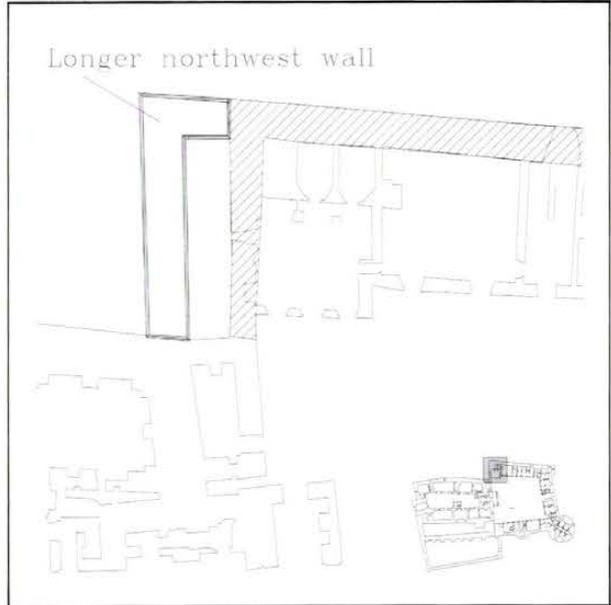
Fig 38. With reference to his own studies on the main part of Turku Castle, Knut Drake suggests that the north wall of the outer bailey originally extended further west and that the original NW wall was later replaced by the present wall.

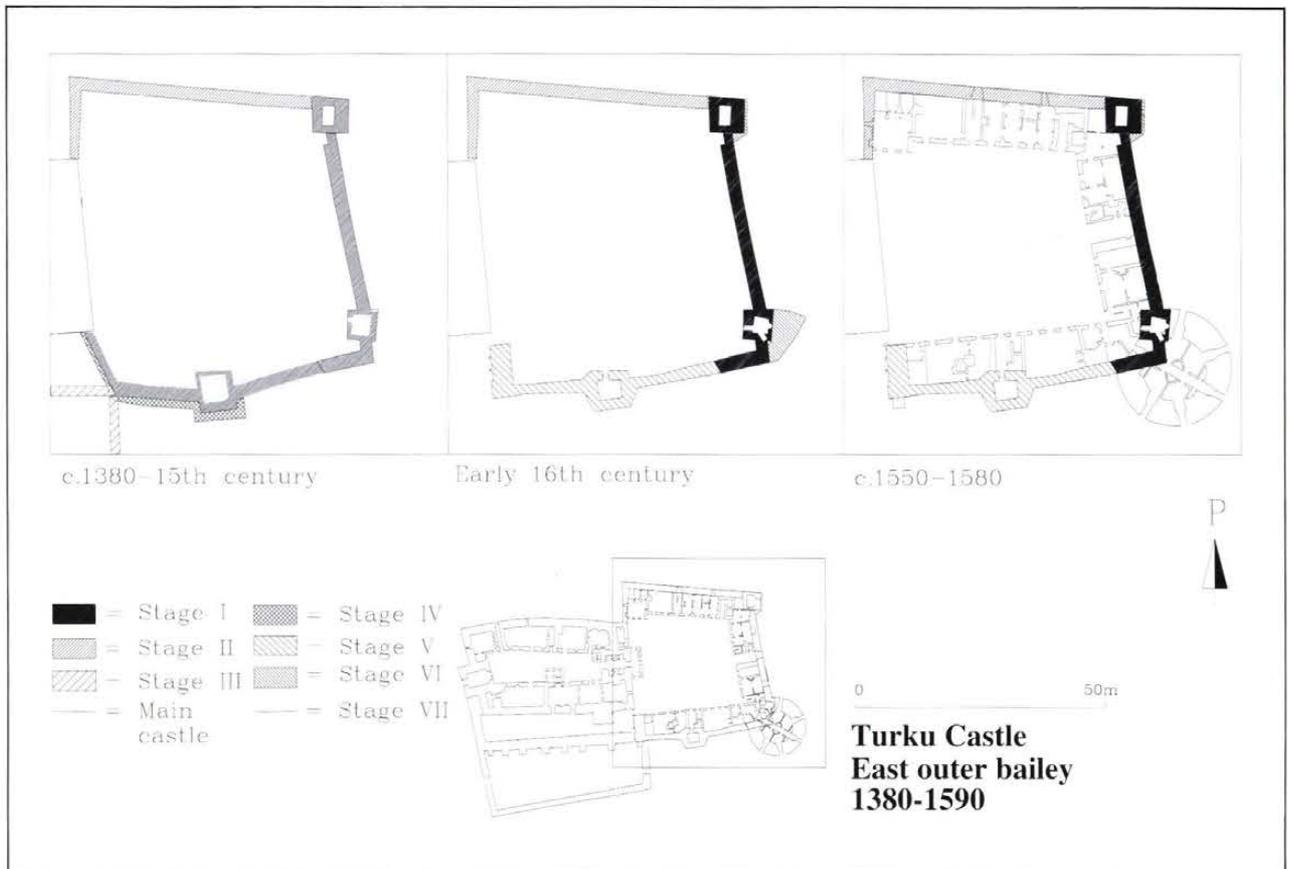
Fig. 40. History of construction of the east bailey of Turku Castle
 In the first stage, the south and east walls with three four-sided flanking towers were built. This plan probably included the construction of the north and northeast wall, but for some reason the works were interrupted. In the second stage, repairs to the badly sunken outer bailey were attempted by building at first support structure, at least in the south wing, and then by renewing the whole wall. Repairs were also carried out in the southeast and northeast towers. In the third stage, a brick extension was built on top of the old walls of unworked stone and the towers. This component was of large bricks in Polish bond. Three-storey buildings were later built within the higher walls. (Illustration by K. Uotila)

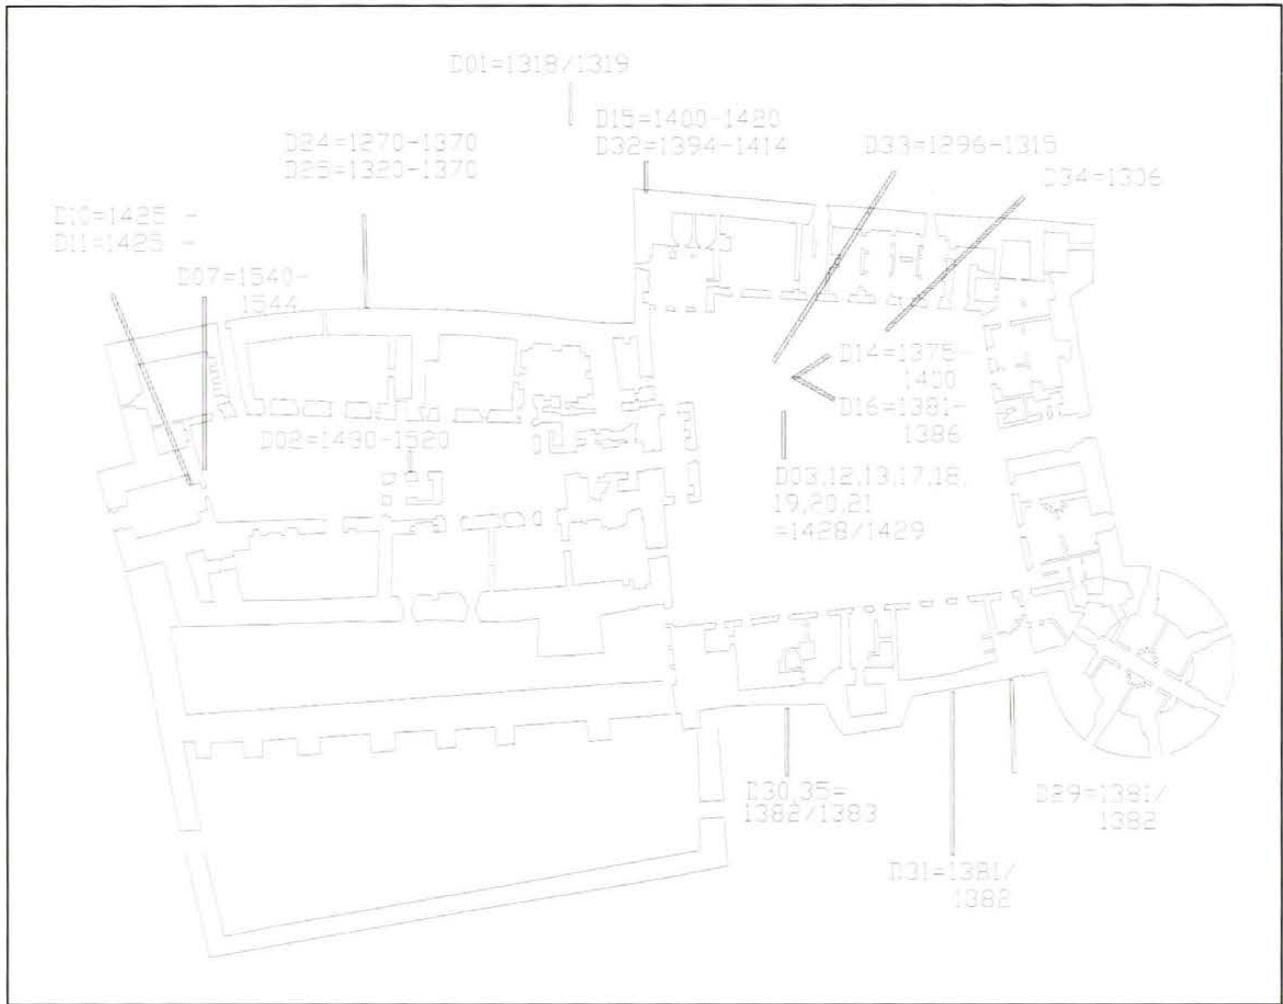
Fig 45. Plan of Turku Castle showing the location and dates of dendrochronological samples analysed in the 1990s (D=FIT). (Drawing by K.Uotila)

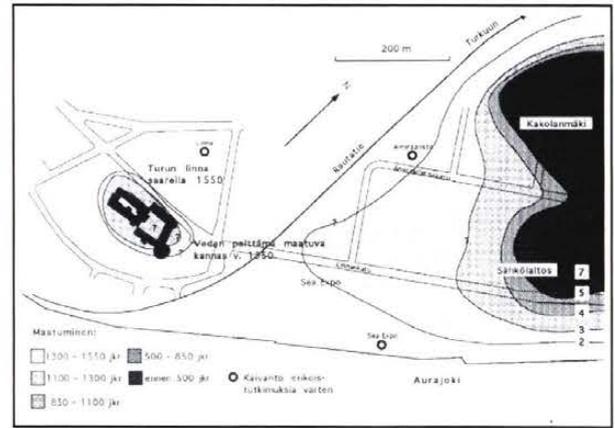
Fig. 50. The development of the environs of Turku Castle during historically recorded times as indicated by geological studies. According to studies by Glückert, the site of Turku Castle was an island until the 1550s. There is little geological data pertaining to the castle island, and the interpretations are therefore questionable. The geological information, however, suggests that the area of the whole east bailey and the upper south ward became dry land already in the period 1100-1300 AD. (Illustration Glückert & Paatonen 1993, p. 13, fig. 3).

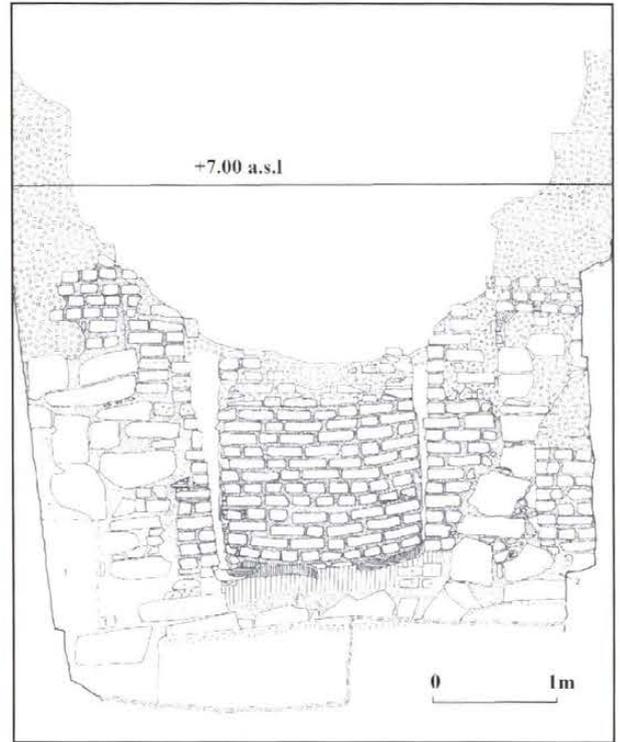
Fig. 61. The west wall of tower C of Kuusisto Castle. The west wall of tower C originally had a brickwork opening facing outer bailey I, but this feature was already walled up during the Middle Ages. All corners of the tower had a brick pilaster, suggesting that the bottom storey was vaulted (The archives of the Dept. of Monuments and Sites, NBA. Kuusisto Castle.).

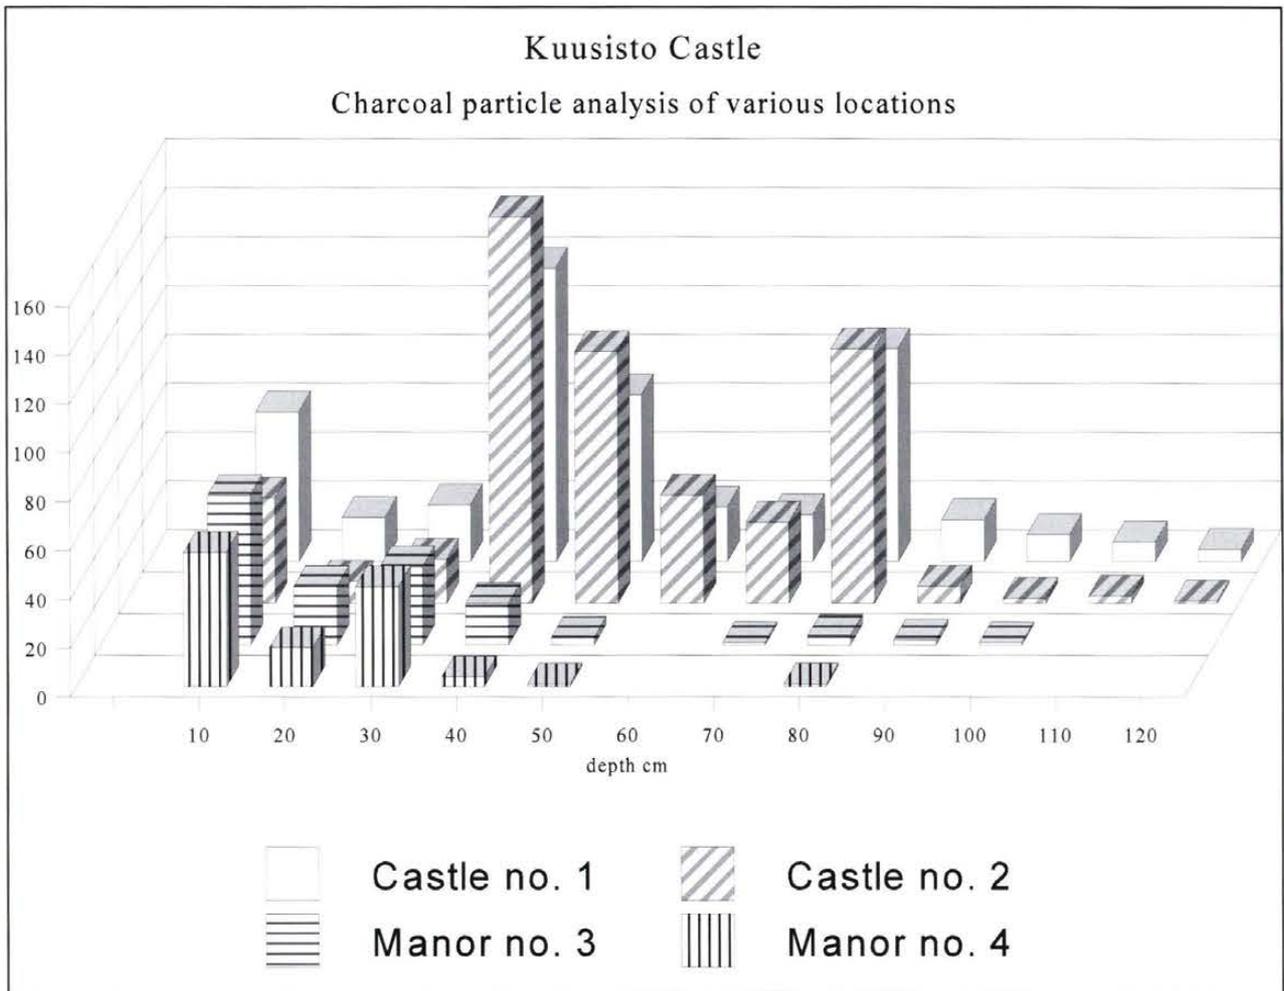
Fig 66. Charcoal particle analysis of Kuusisto Castle and environs.
