Kari Uotila

Medieval Outer Baileys in Finland
With Special Reference to Turku Castle

Turku 1998

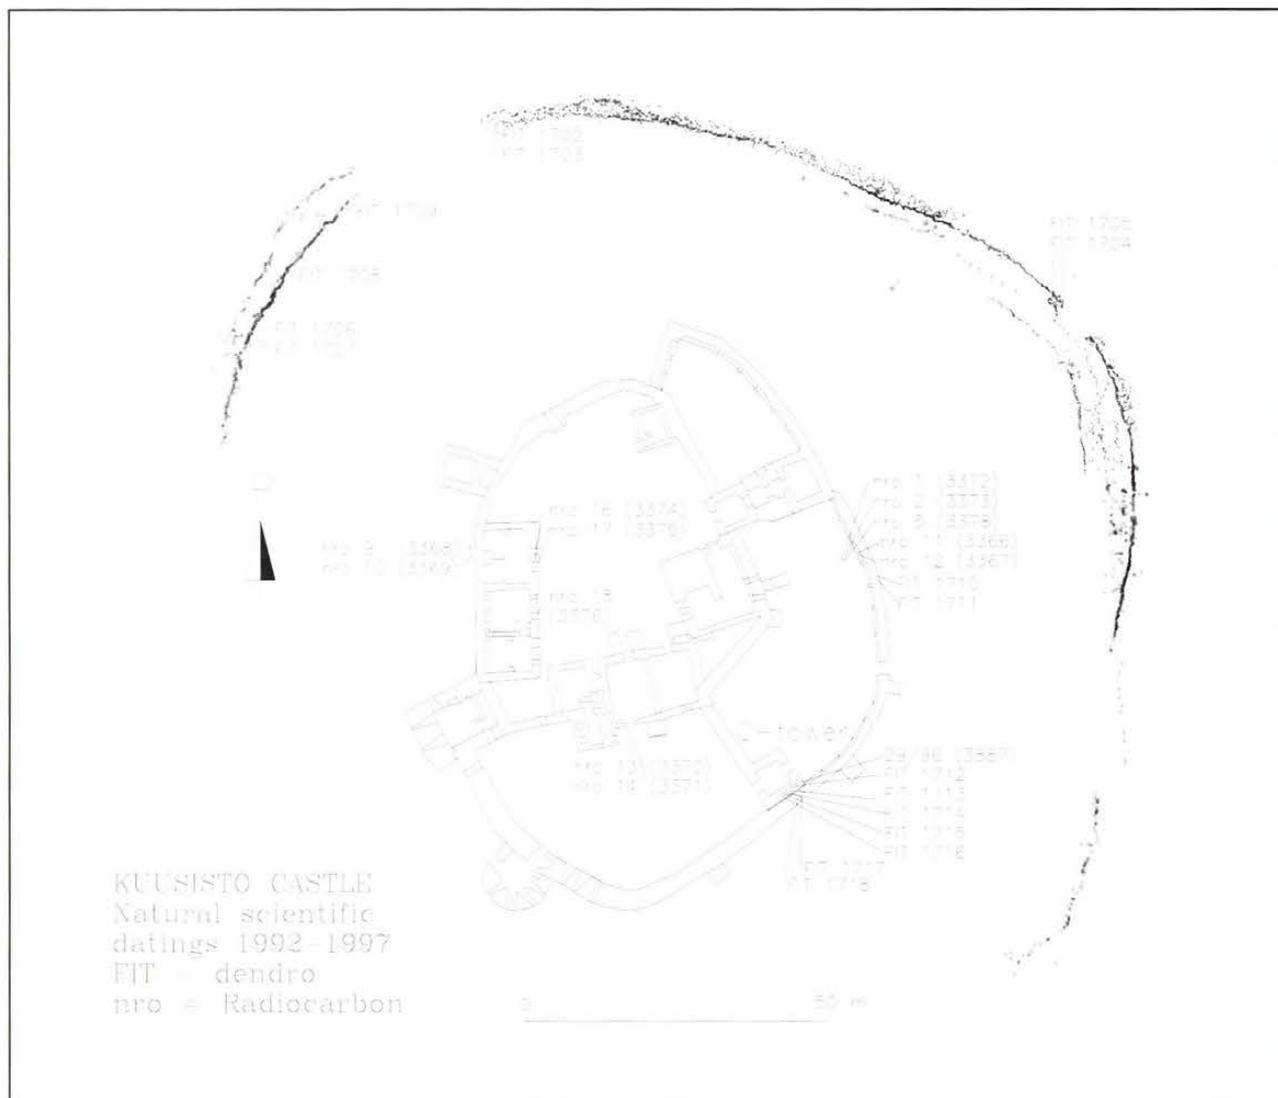
Fig 67. Samples for scientific dating procedures taken from the area of Kuusisto Castle 1992-1997. The dendrochronological samples are prefixed FIT and the radiocarbon samples are given a sampling number and a Hel designation in parentheses. (Drawing by K. Uotila)

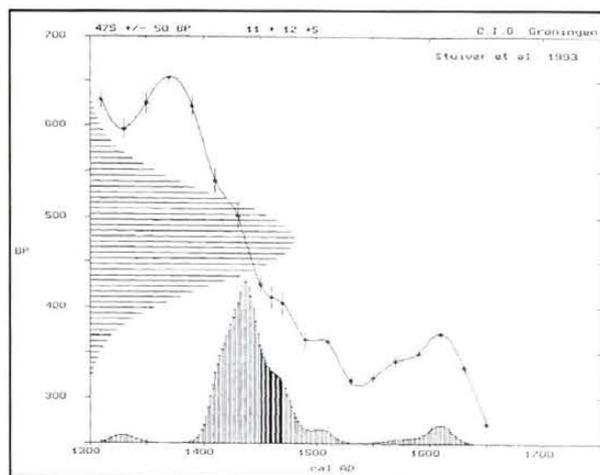
Fig 68. Radiocarbon dates of the east encircling wall of outer bailey I of Kuusisto Castle. Mortar samples Hel 3366 and 3367 were taken of the outer wall of the outer bailey, and Hel 3378 from the mortar layer in front of the wall (detailed results in table 4). The compiled date for the three samples falls into the first half of the 15th century, the most probable time of construction being the 1430s. The dendrochronological samples (FIT 1710-1711) show the foundation post of the wall to have been felled in the winter of 1438-39. (Fig. Jungner 1994a)

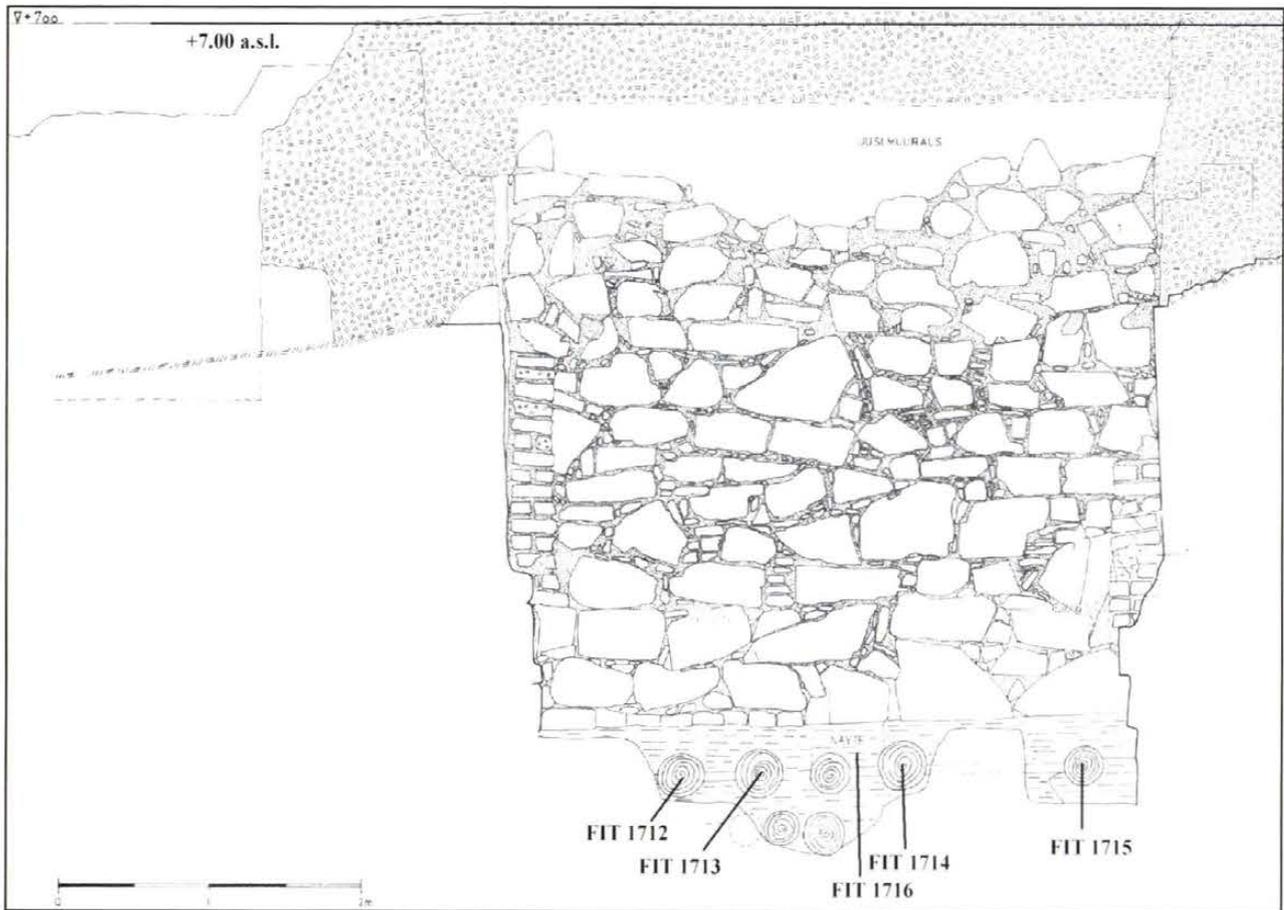
Fig. 69. The log foundation and stonework of tower C of Kuusisto Castle. Tower C was built on top of a thick clay layer and the tower was built on a four-course log framework, in which the lowest course of logs was at elevation ca. +1.50 a.s.l. Five timber samples of the framework were taken (FIT 1712-1716), which have been dated to the 1430s. (The archives of the Dept. of Monuments and Sites, NBA, Kuusisto Castle.)

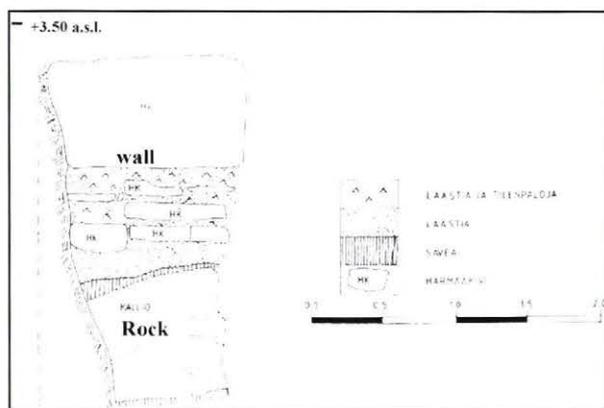
Fig. 70. Foundation of the west wall of tower 12 of Kuusisto Castle. Tower 12, located on the northwest side of the main castle, was built on bedrock as a mortared stone wall at elevation ca. +1.70-+1.80 a.s.l. (The archives of the Dept. of Monuments and Sites, NBA, Kuusisto Castle.)

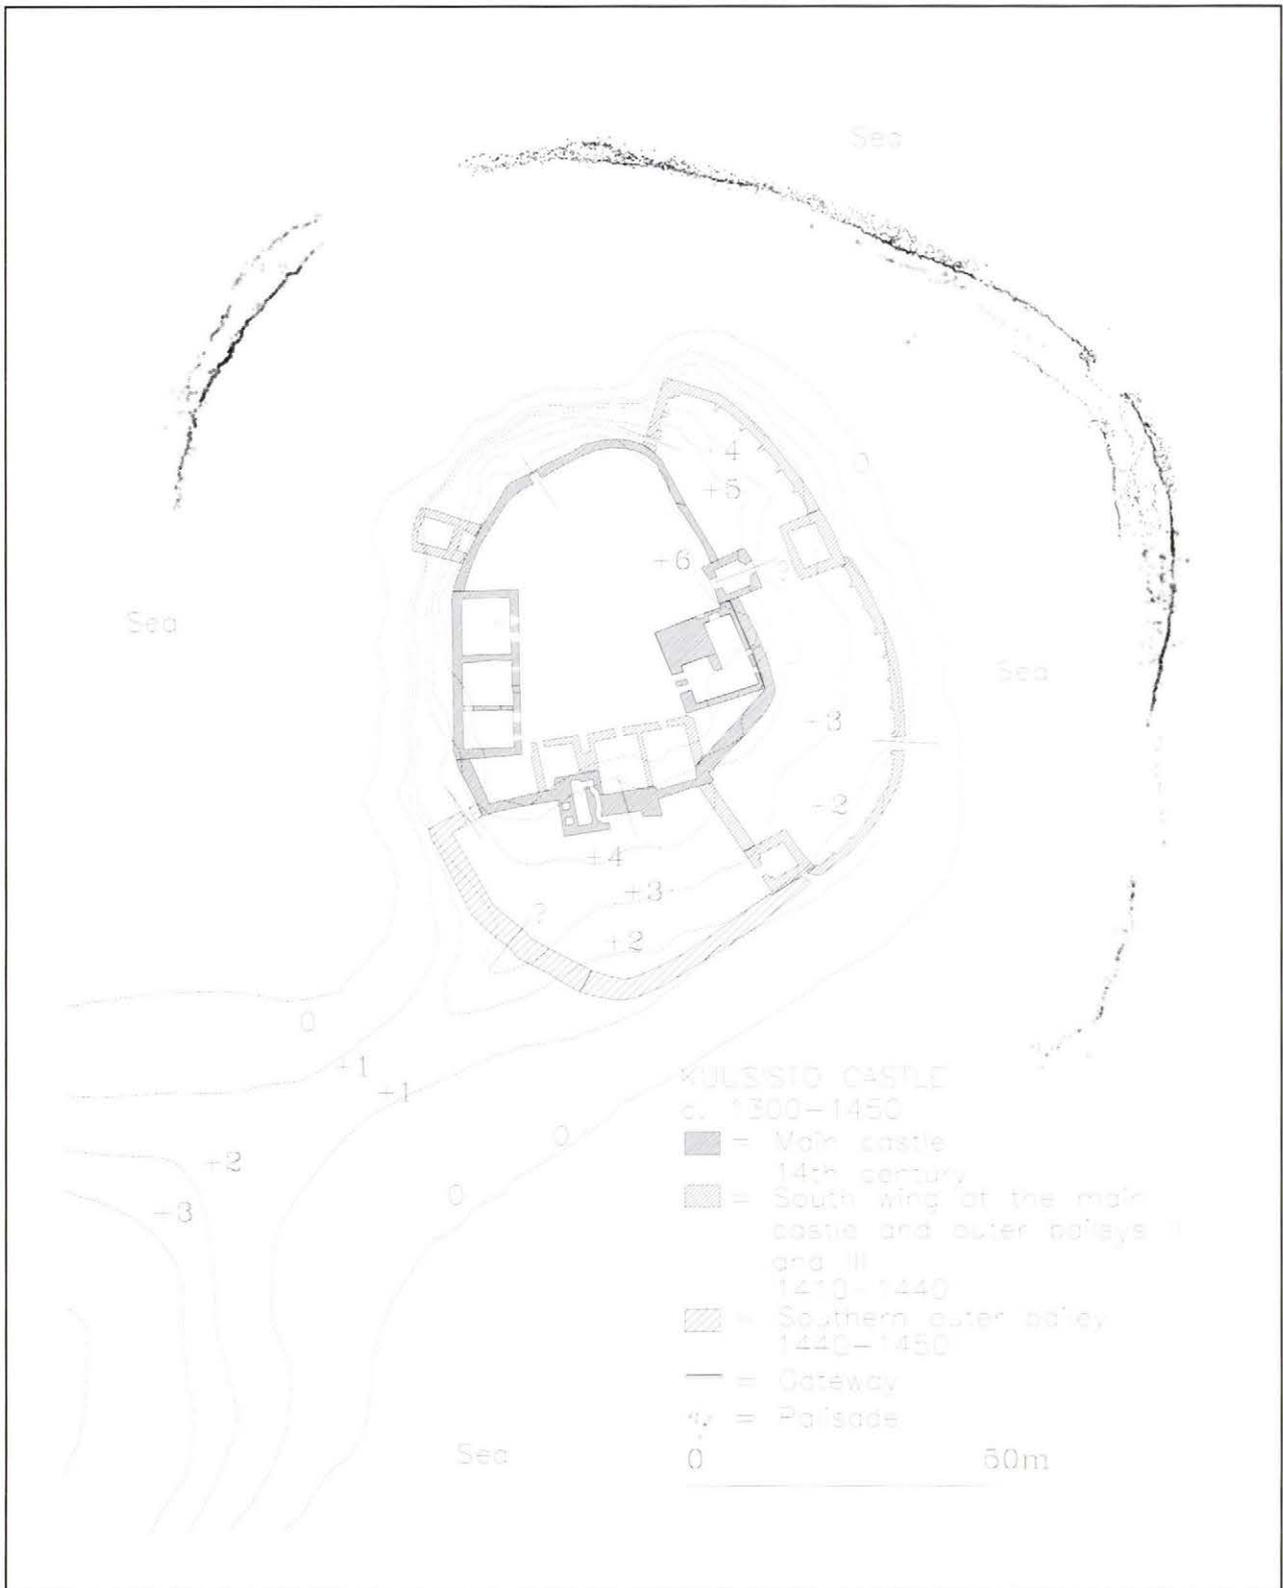
Fig. 71. History of construction of Kuusisto Castle, ca. 1300-1450.

The encircling wall of the main castle and the masonry buildings of the west and east wings can be dated to the 14th century, but extensive construction probably began in the first half of the 15th century, perhaps during the term of Bishop Magnus II Tavast in 1412-1450. Around 1410 the extensive palisade encircling the castle was built. The actual building work possibly came under way in the southern palatial section of the main castle in the 1420s, from where it expanded into the outer baileys in the late 1430s. In the outer baileys works began with the construction of towers C and D, followed by the brick-arched walls of outer baileys II and III. The encircling wall of outer bailey I was probably built during this stage. (Drawing by K. Uotila)

throughout the 1430s, probably until the 1440s. It is also possible that the enlargement of the castle probably began in the 1410s and 1420s, when Kuusisto is first mentioned as a castle (Fig. 71).¹

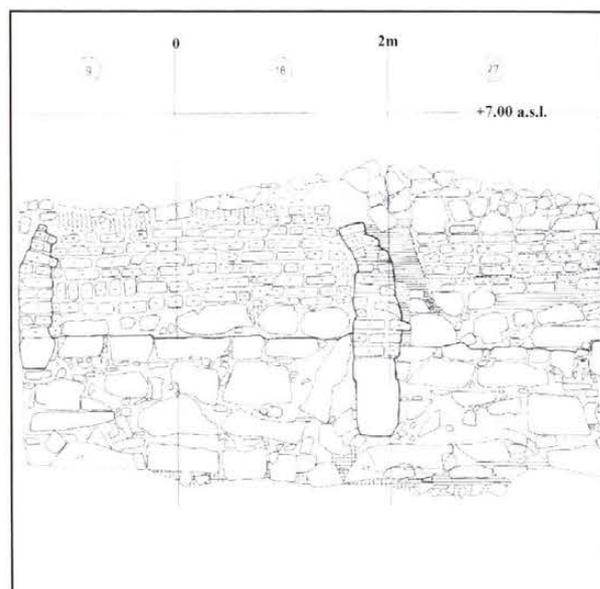
Fig. 72. The east section of the wall surrounding outer bailey II of Kuusisto Castle (view from the west). The original brickwork was revealed in excavations conducted in the 1980s. Beneath the later conservation layers was the original wall structure, with a threshold on top followed by brickwork with the remains of large brick arches. (The archives of the Dept. of Monuments and Sites, NBA. Kuusisto Castle.)

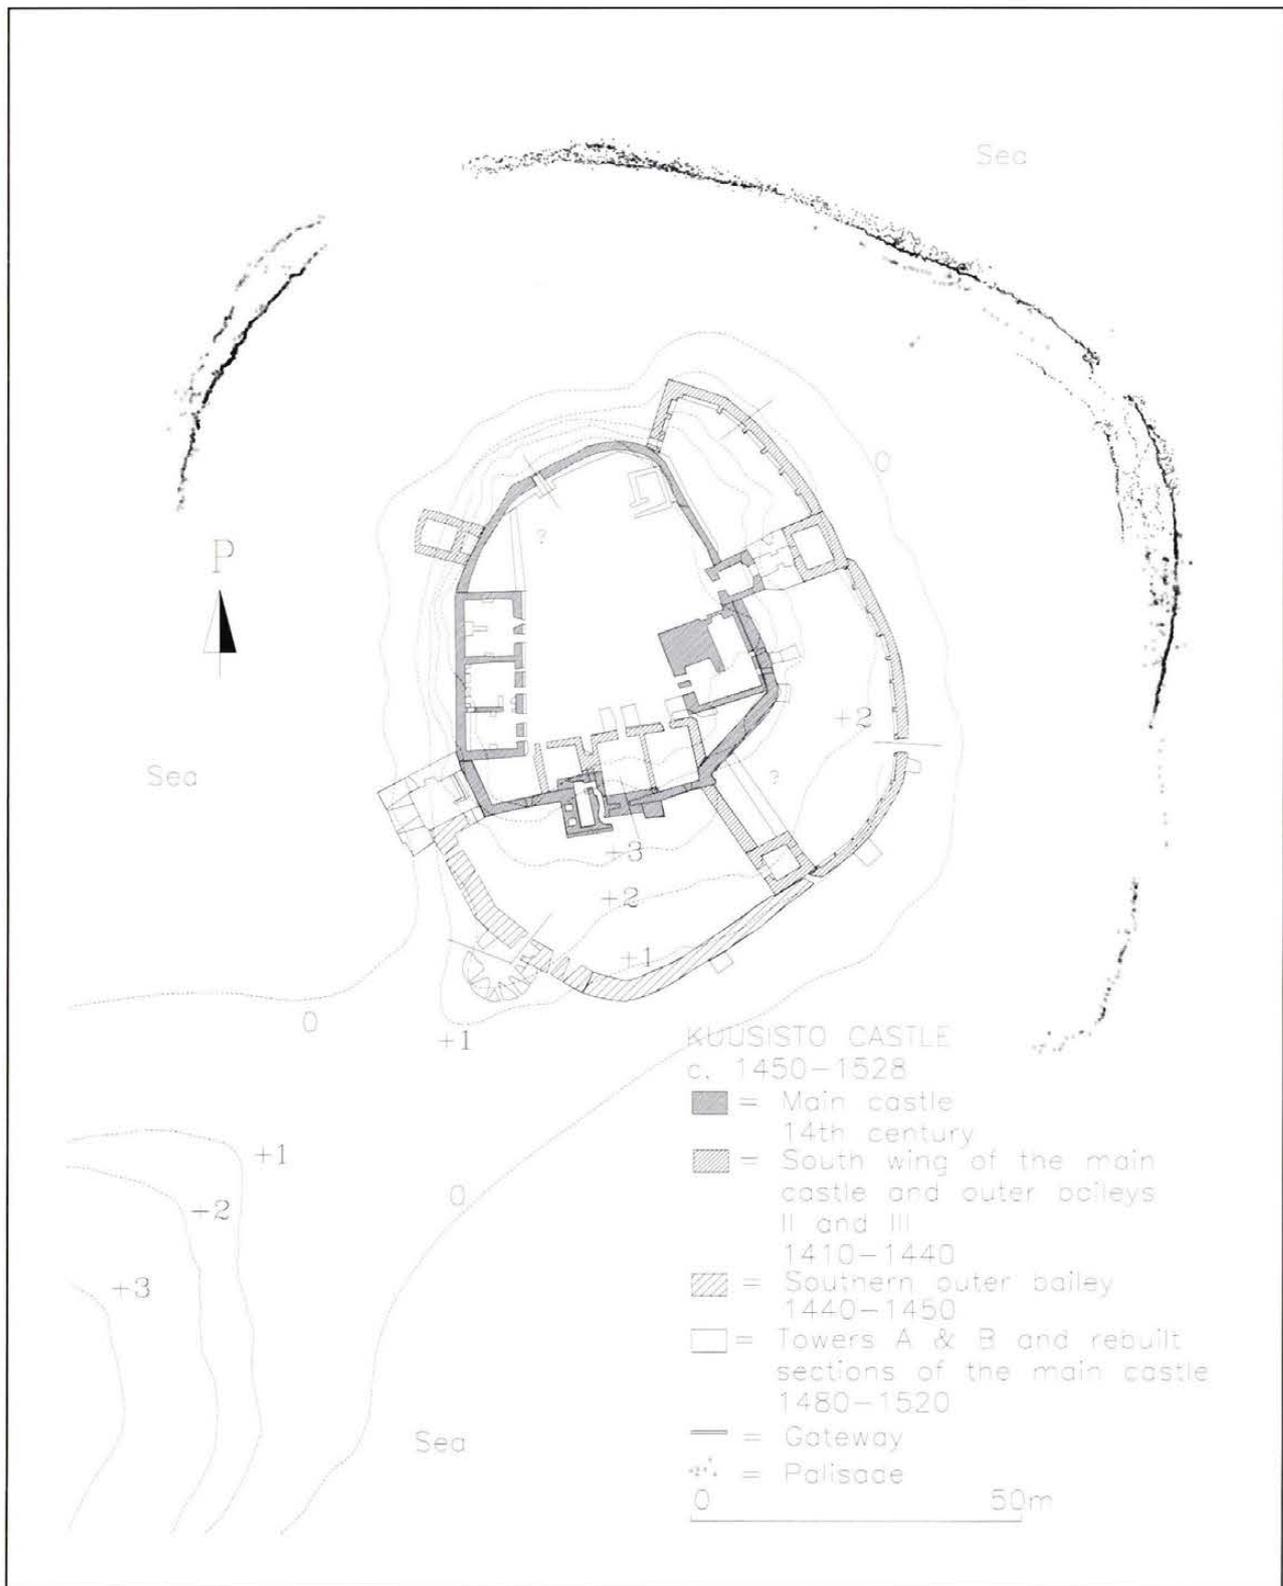
Fig. 73. History of construction of Kuusisto Castle, ca. 1450-1520.

In the late 15th and early 16th century the castle did not appreciably grow in area. The defence of outer bailey I was significantly improved with the construction of two cannon towers (A and B) and by renewing its walls. After the works, over ten embrasures faced the main island of Kuusisto. Elsewhere in the castle, renewal mainly concerned raising the height of the main castle and the outer baileys. (Drawing by K. Uotila)

In many places, the oldest walls and towers of the outer baileys were built on clayey soil. The bearing properties of the structures changed during the 15th and 16th centuries. Some of the structures were on a hard foundation (moraine or bedrock), while others stood on clay, which led to large fissures and cracks at the locations of different foundations. There were no major problems with outer bailey II and tower D, but the wall and gateway of outer bailey II clearly sank towards the east and at a few joints, the movement of the structures also damaged upper structures such as the timber firing platforms. The problems also extended to tower C, which leaned towards the south by several degrees. In the area of outer bailey I, the walls leaned towards the south (Fig. 73).

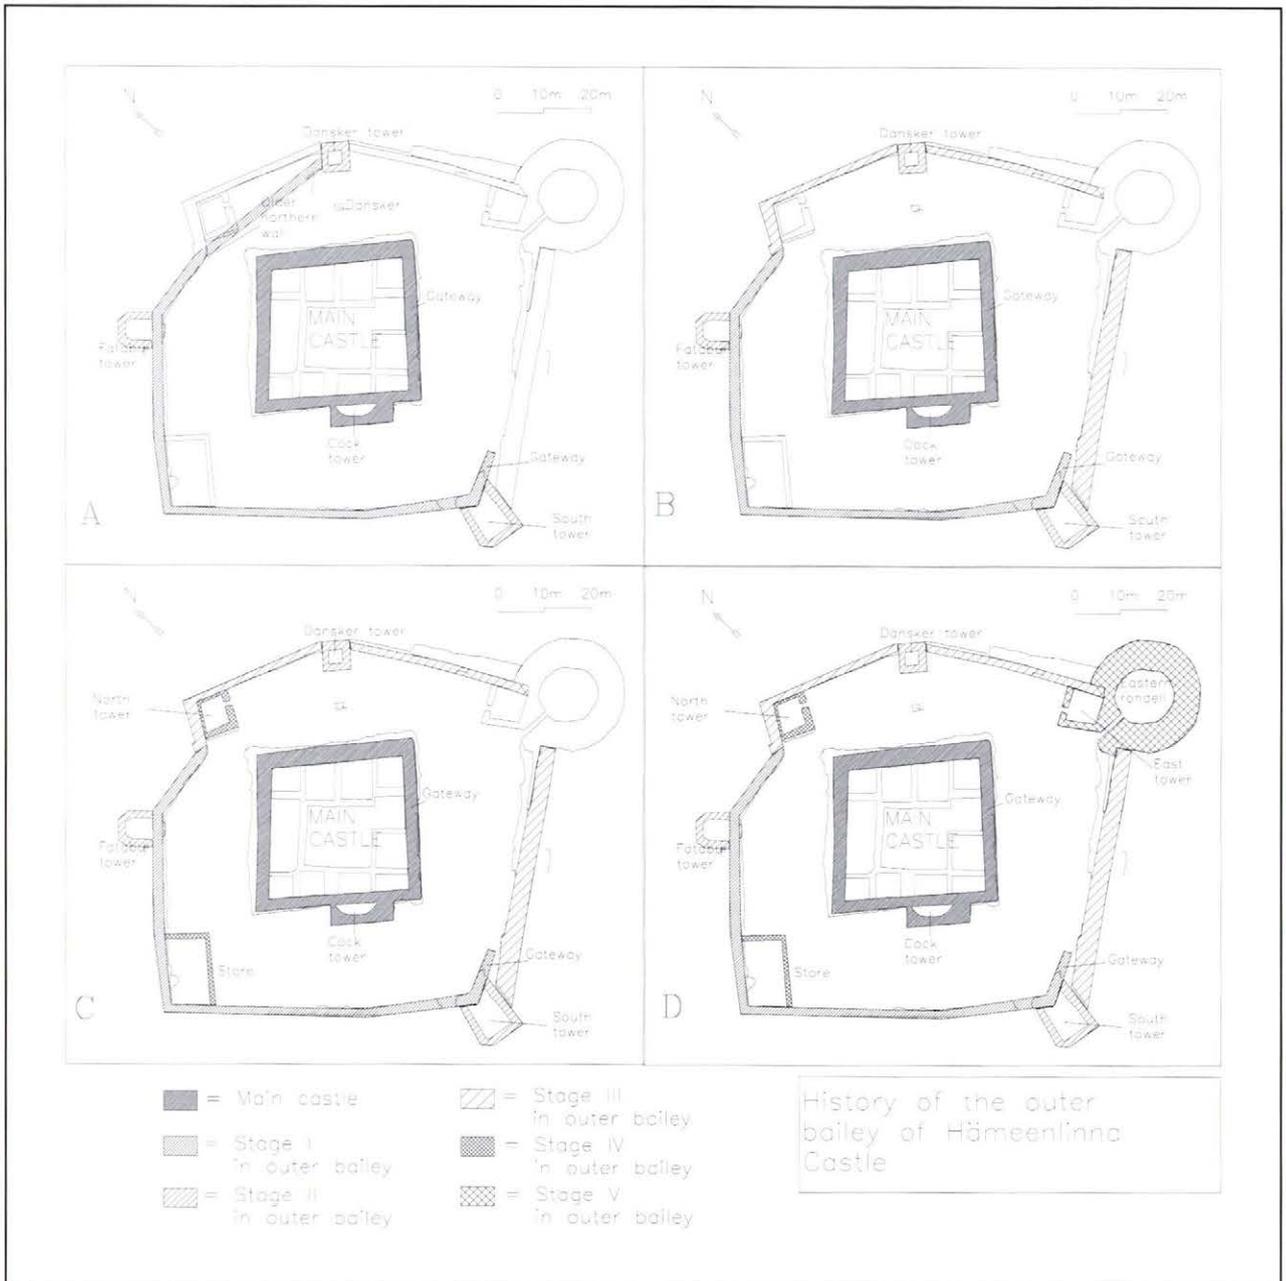
Fig. 78. Architectural history of the outer bailey of Hämeenlinna Castle according to research by Drake (in 1960s) and Luppi. (Drawing by K. Uotila)

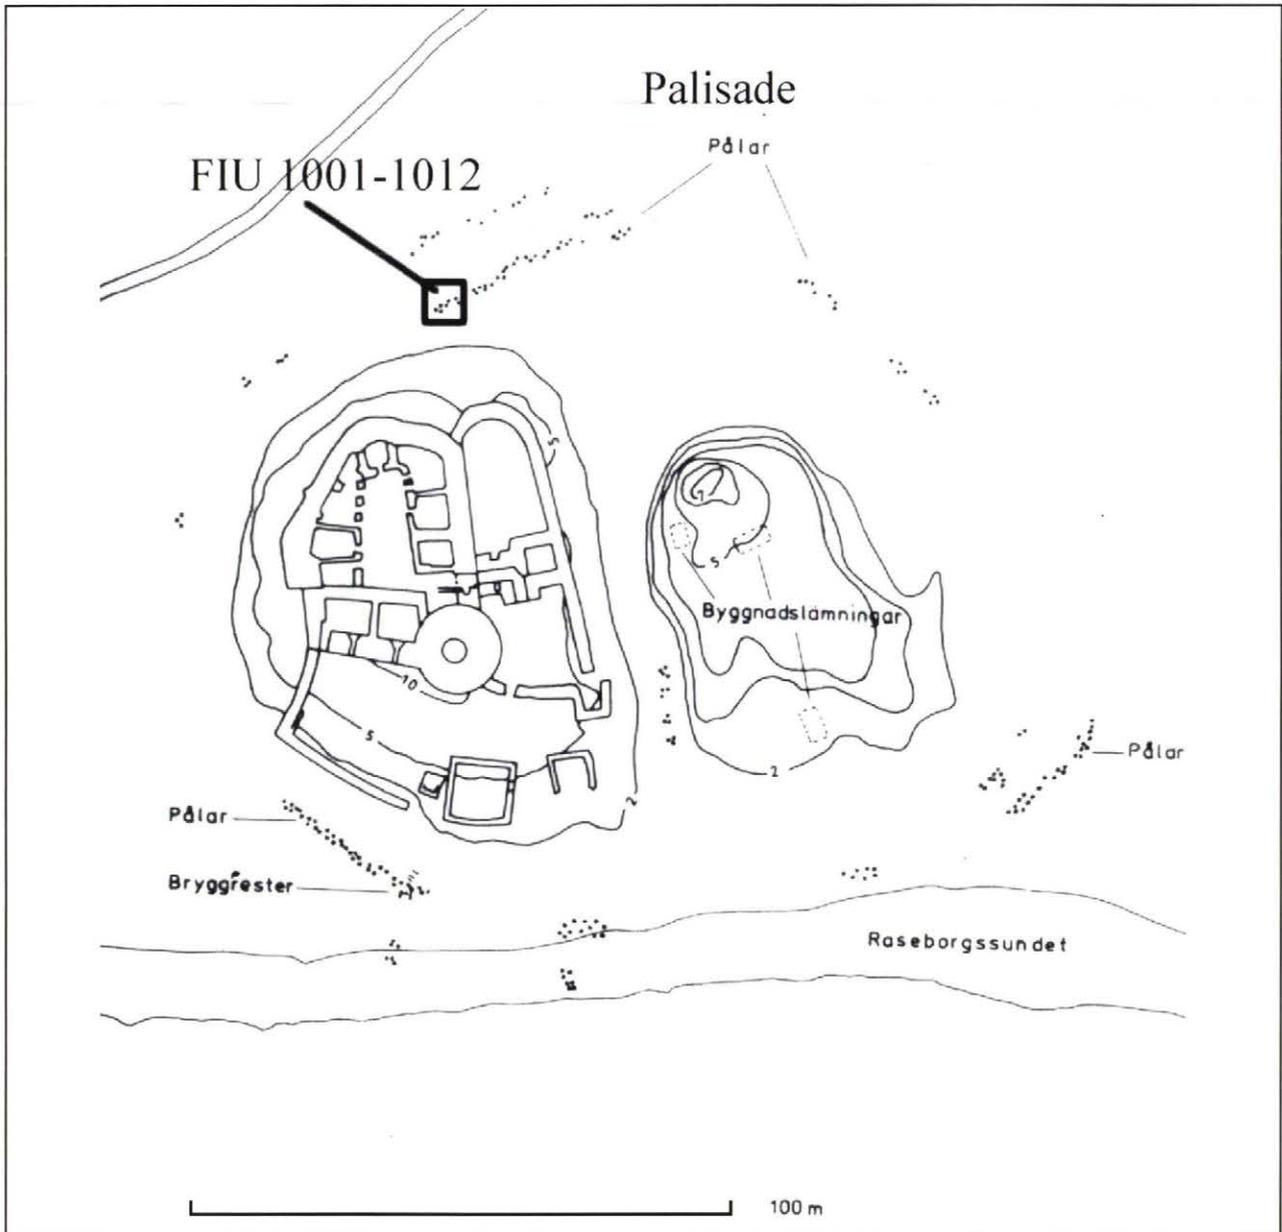
Fig. 83. The palisade of Raasepori Castle and dendrochronological datings FIU 1001-1012 (Drake 1991, p. 92 and Zetterberg 1992 p. 2).

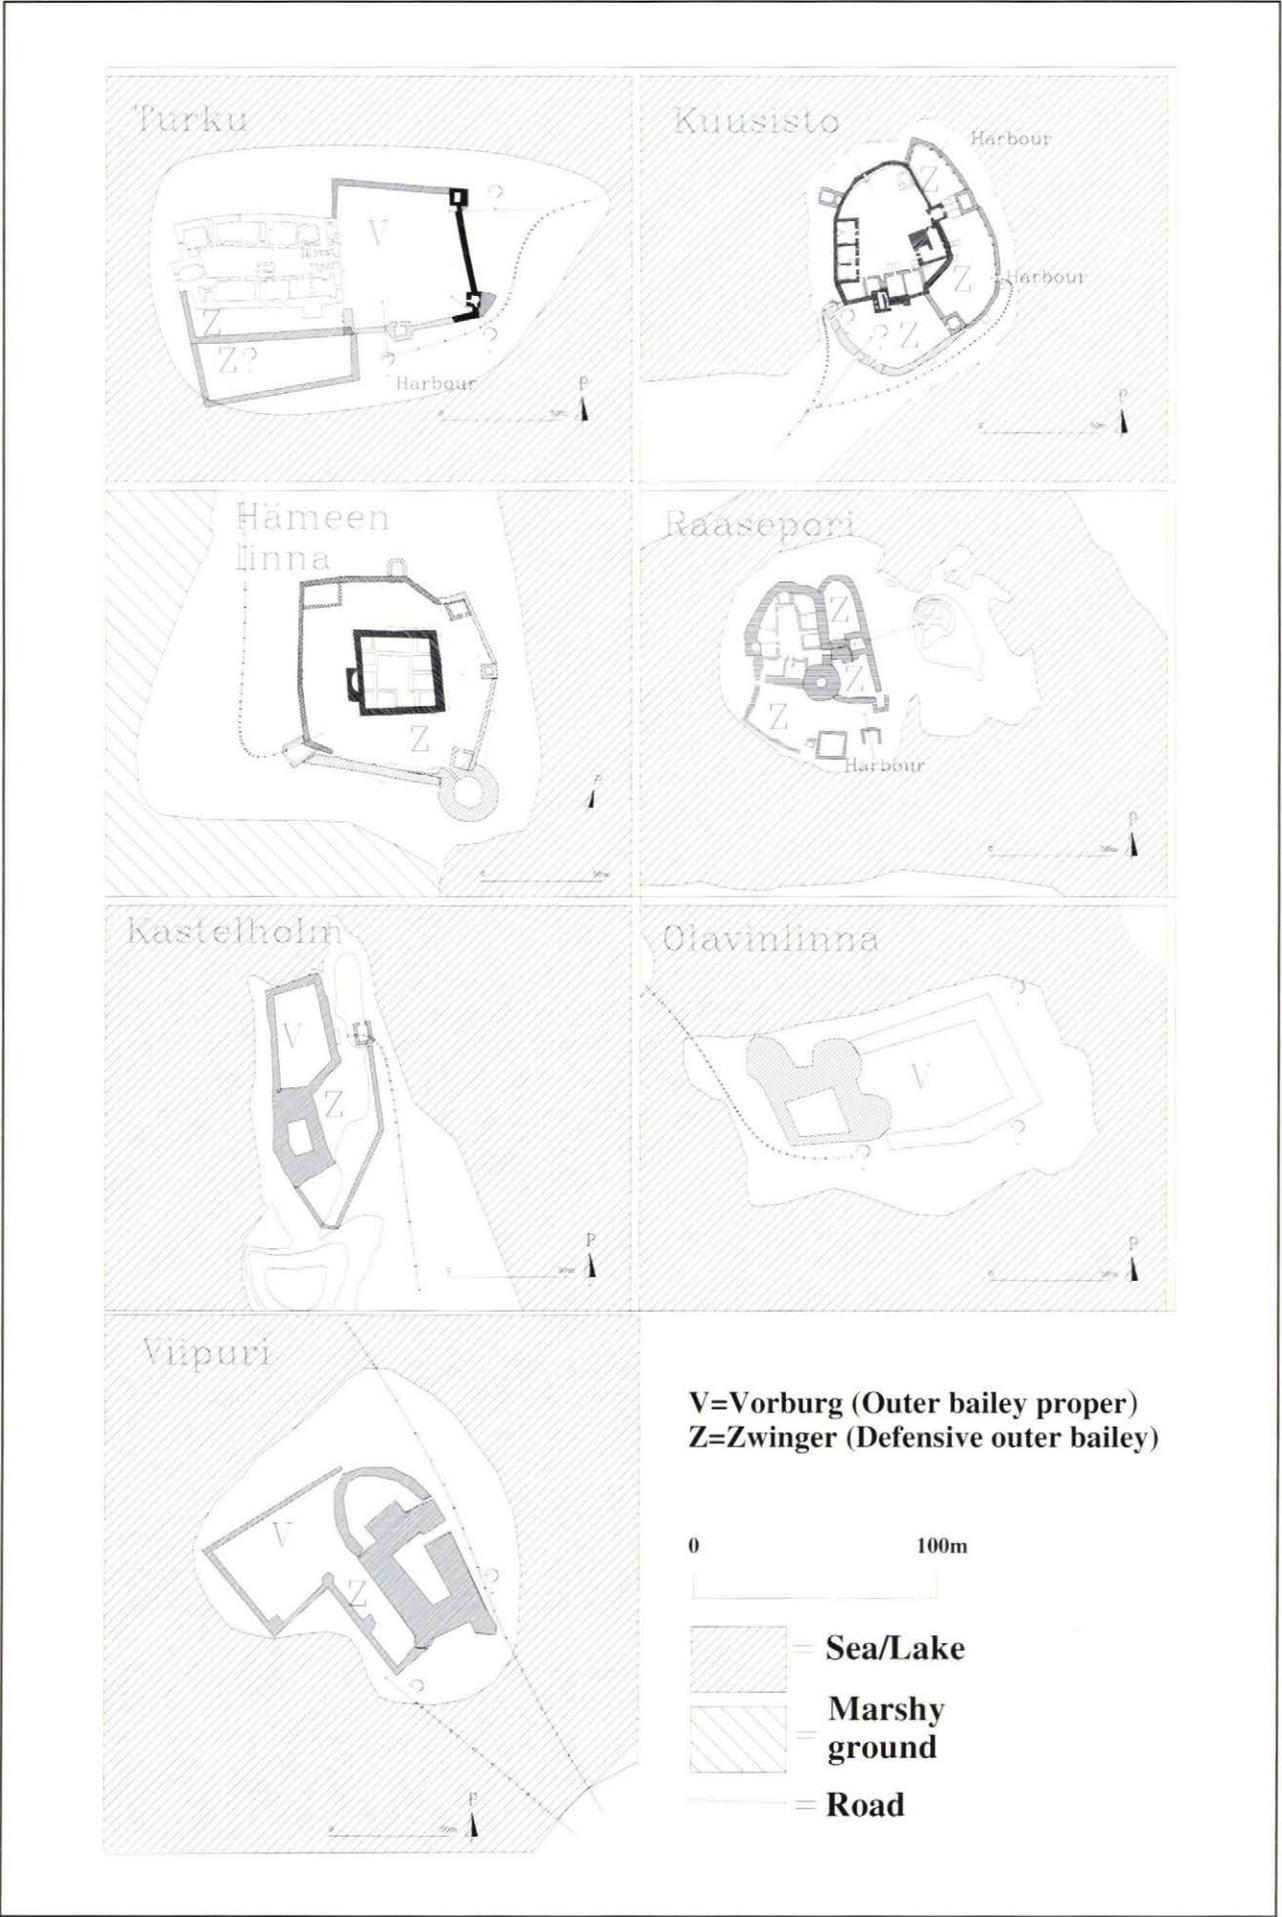
Fig. 90. The components and routes of access in the outer baileys (Drawing K. Uotila).

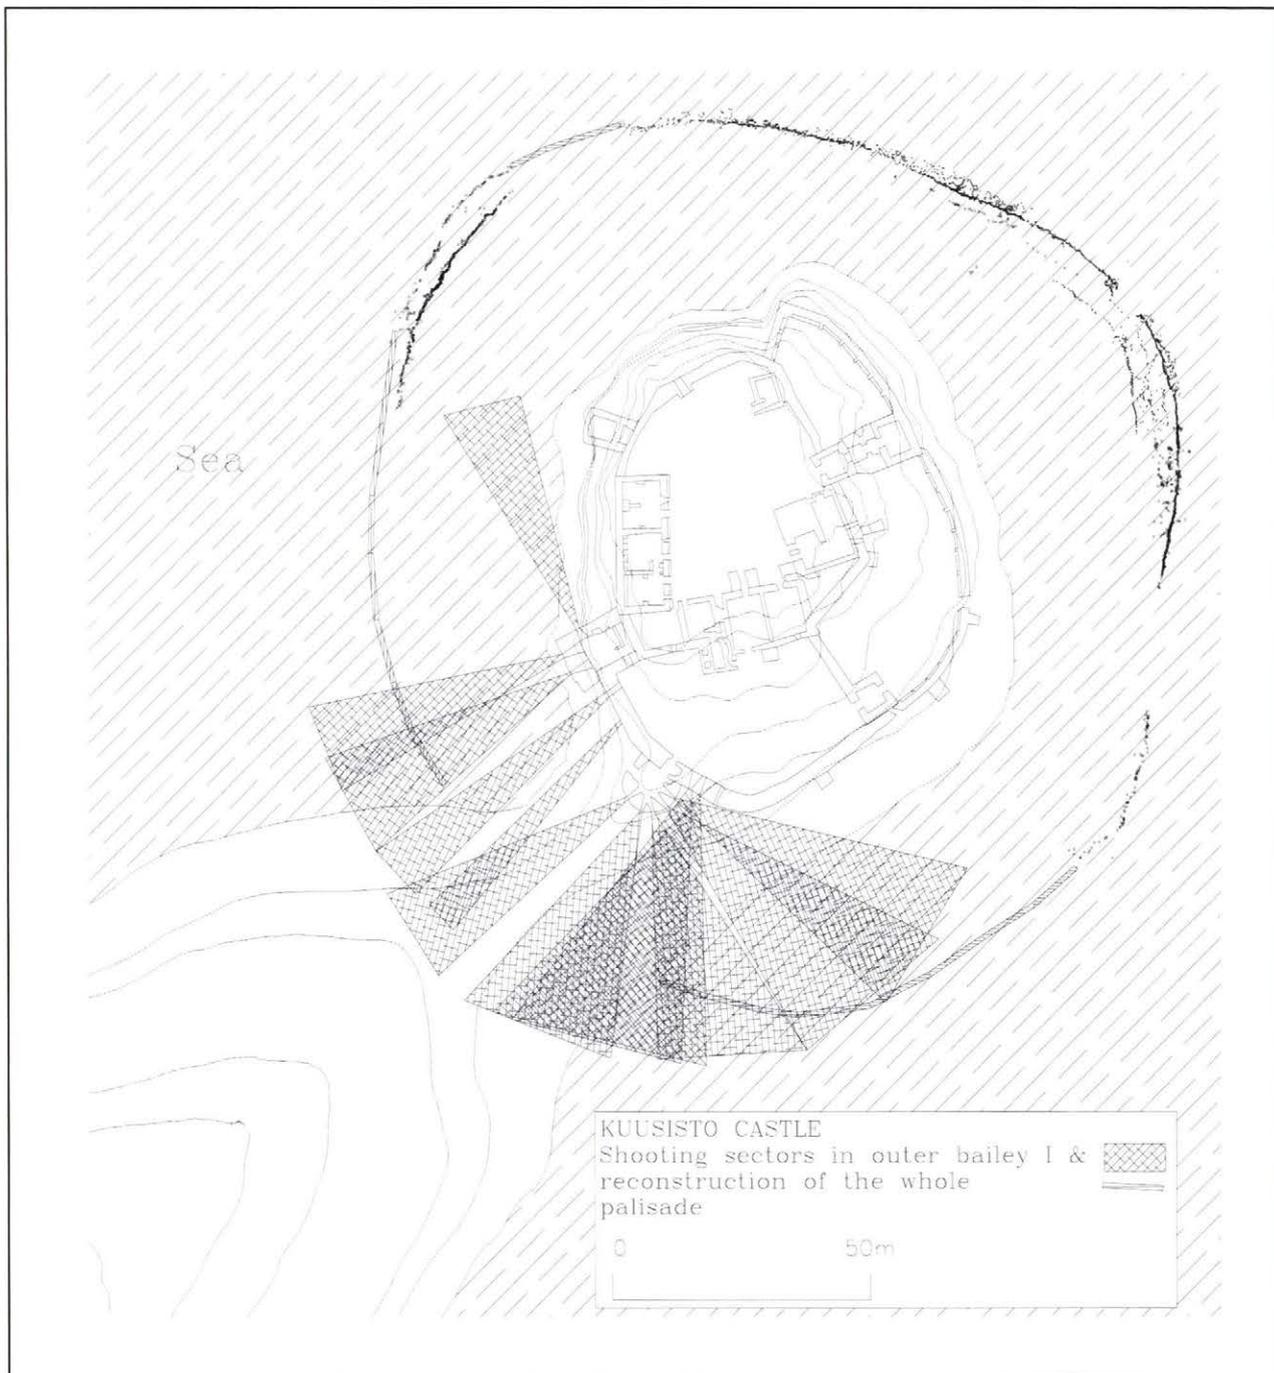
Fig. 91. The defensive structures of outer bailey I of Kuusisto Castle. Over ten embrasures for cannon were built in the walls of outer bailey I and towers A and B (ca. 1480-1520). Fire from these locations covered the land route connecting with the main island of Kuusisto. Moreover, fire from most of the cannon extended to the shore areas (particularly towards the south). In this illustration the efficient sector of the cannon is given as ca. 50 metres. The illustration includes a reconstruction of the palisade. (Drawing by K. Uotila).

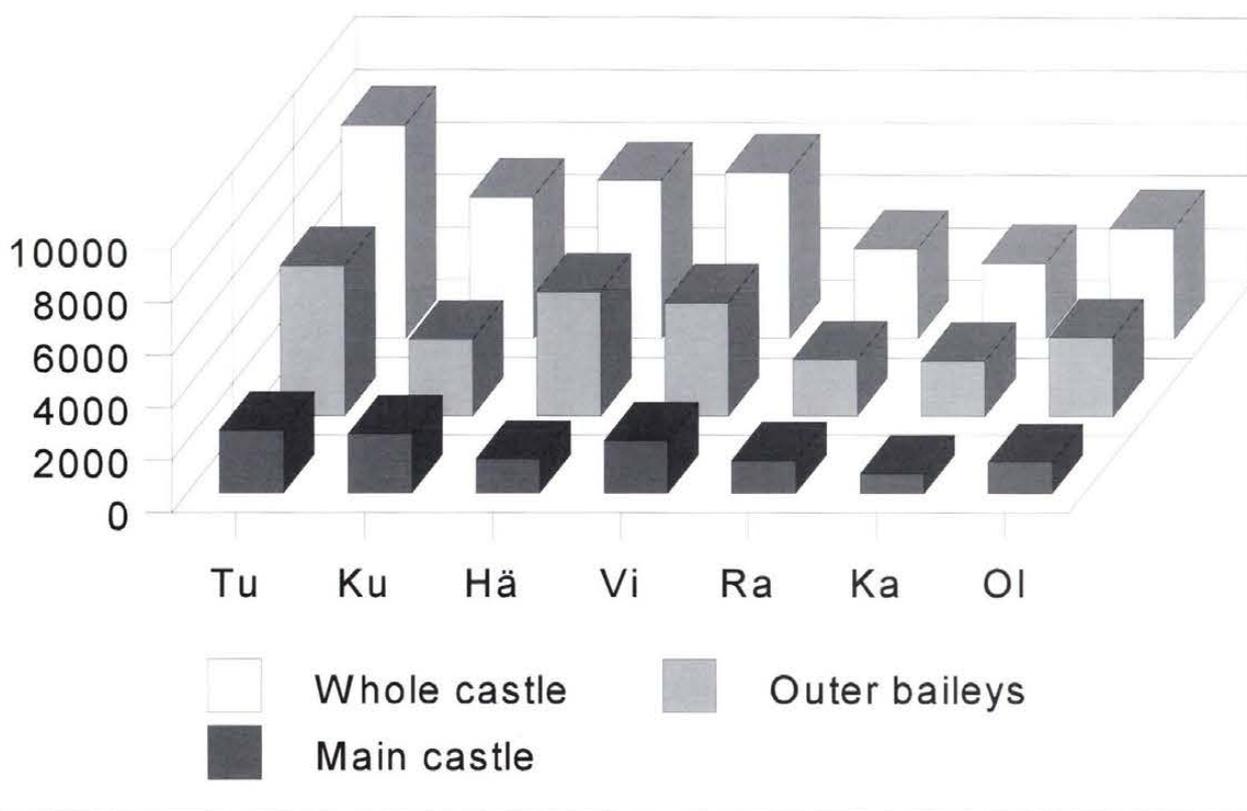
Fig. 94. Areas (m²) of medieval castles in Finland (main castle and outer bailey) ca. 1520. Tu = Turku Castle; Ku = Kuusisto Castle; Hä = Hämeenlinna Castle; Vi = Viipuri Castle; Ra = Raasepori; Ka = Kastelholm (Drawing by K. Uotila).

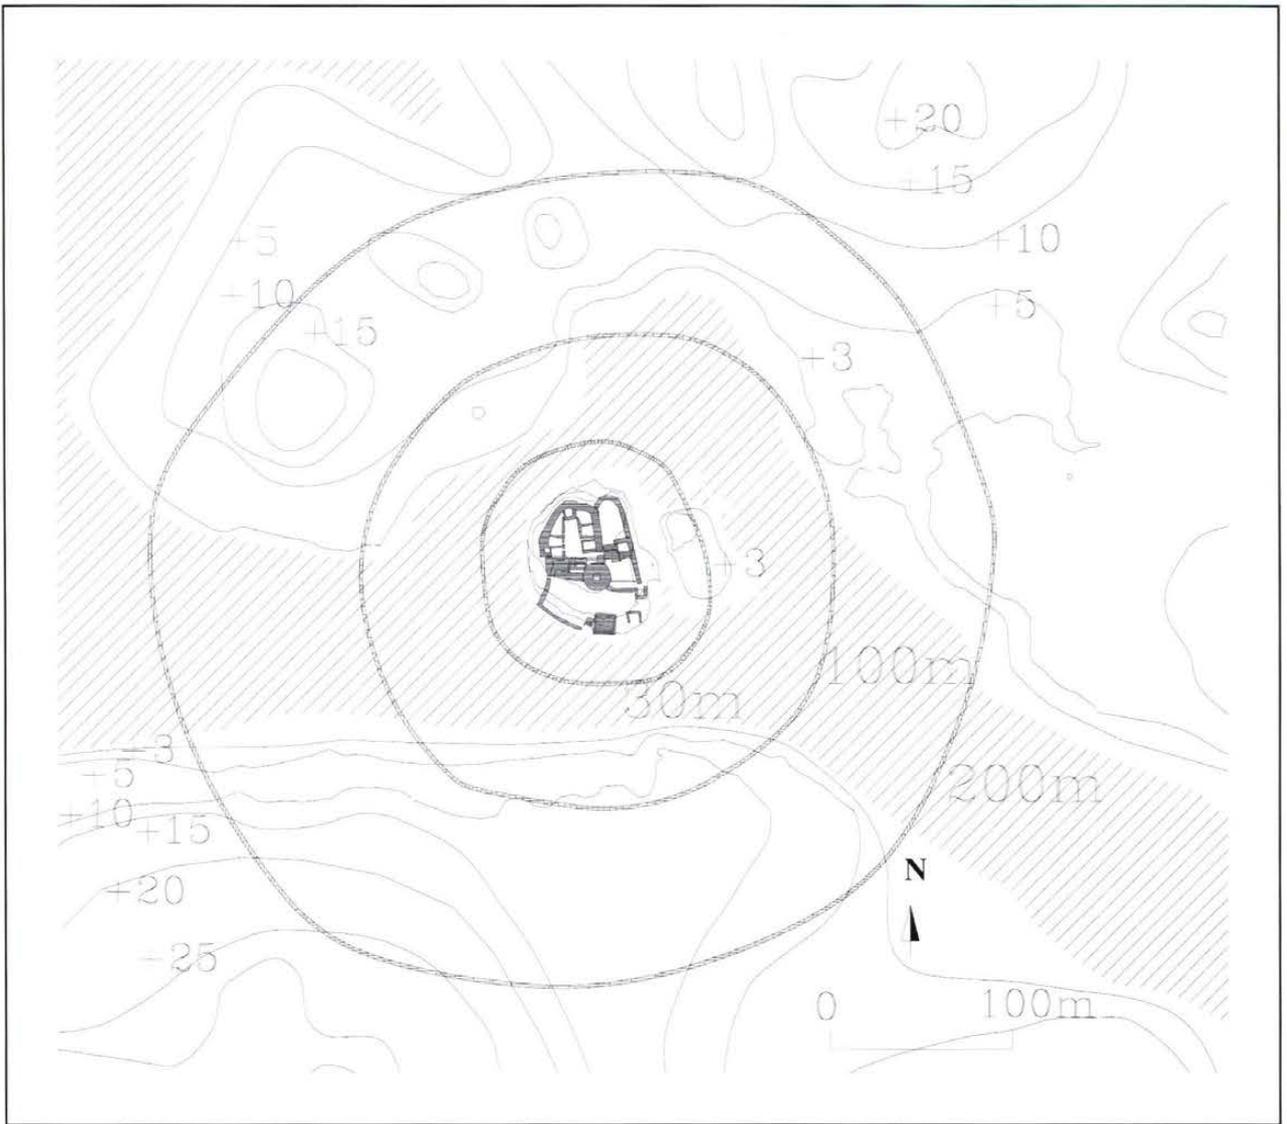
Fig. 99. Environs of Raasepori Castle in the Middle Ages. The location of the castle among high rocky hills was difficult in terms of defence, for the castle could be fired upon with cannon from several directions. (Material from the Archives of the Department of Monuments and Sites, NBA, Raasepori. Drawing by K. Uotila)

At Raasepori Castle, the nearest areas of high elevation are on the opposite bank of the Raasepori River at a distance of approximately 100 metres from the castle (Fig. 99). At Kastelholm in turn the nearby high rocky hill was over 200 metres from the castle (Fig. 100) and the situation was much same in Olavinlinna (Fig. 101).

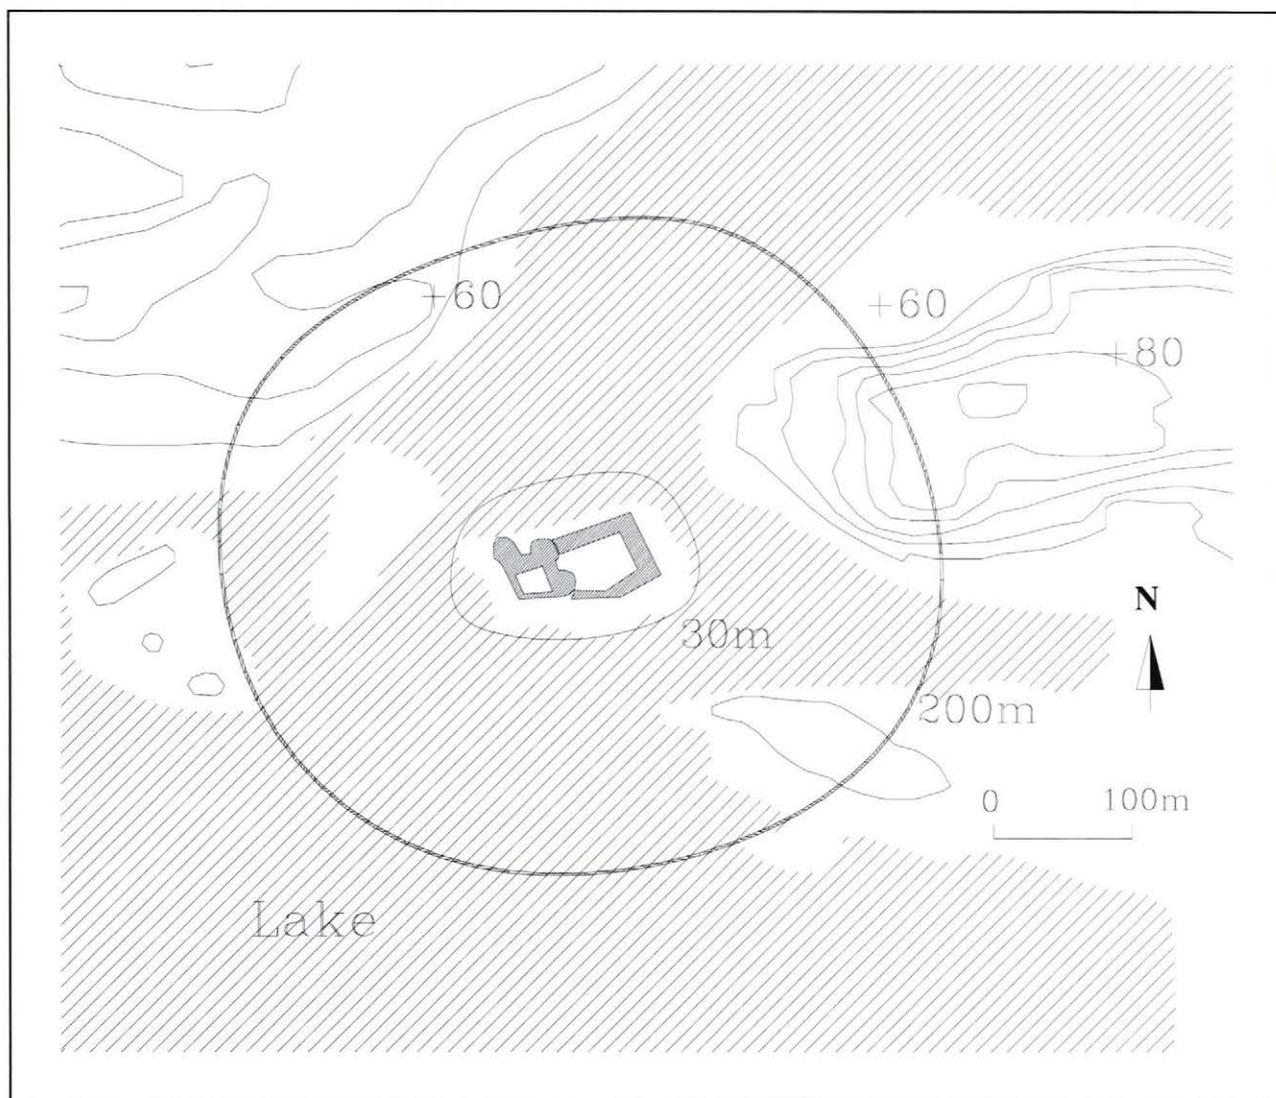
Fig. 101. Environs of Olavinlinna Castle in the Middle Ages.

The walls of the main castle and outer bailey cover the whole small island of the site. Within cannon range, however, was nearby Tallisaari island and large tracts of land on both sides of nearby Kyrönsalmi strait (Material from the Archives of the Department of Monuments and Sites, NBA. Olavinlinna. Drawing by K. Uotila).

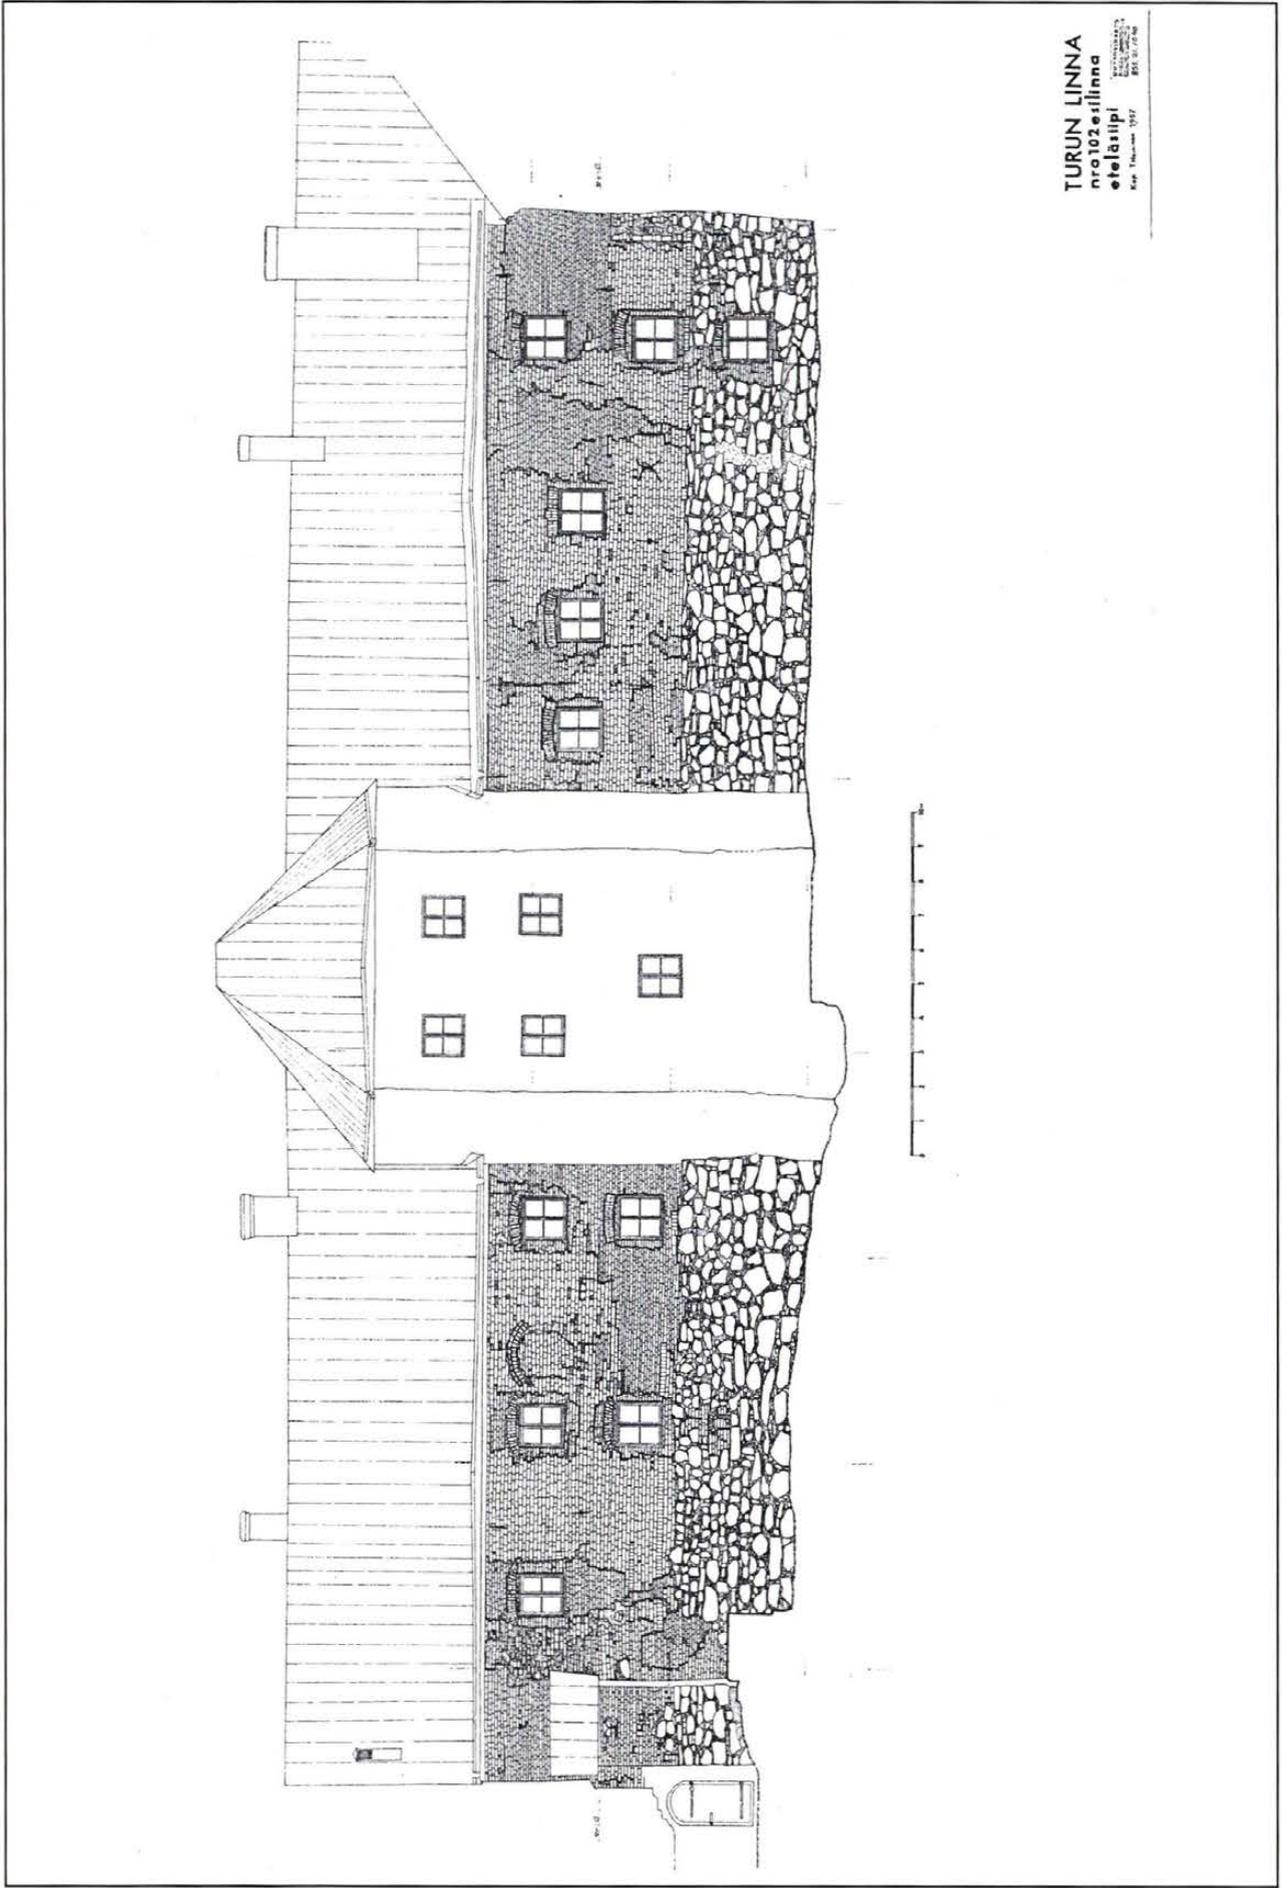
Plate XII.

TURUN LINNA
nro 102 esilinna
eteläsiipi
Kop. Huhtanen 1997
